Transect	Well name ISC	Well ID	Location	Priority	Latitude	Longitude	Height of outer casing (up) - ft	Difference in height between outcasing and inner casing	Depth to Water (ft BTOC)	Total Depth (ft BTOC)	Expected water level fluctuations (ft bgs)
Brown Arroyo	BRN E-01-A	SO-0125	East of Rio	High	34.003032	-106.869709	2.2	0.82	5.7	20.1	2 to 13
Brown Arroyo	BRN E-04-A	SO-0131	East of Rio	High	34.003714	-106.860987	2.35	0.94	2.66	16.92	1 to 6
Brown Arroyo	BRN W-03-A	SO-0140	West of LFCC	High	34.00067	-106.872017	2.24	1.56	12.18	19.91	10 to 14
Brown Arroyo	BRN W-04-A	SO-0142	West of LFCC	Low	34.000651	-106.871465	2.19	1.02	9.5	22.15	8 to 11
Brown Arroyo	BRN W-05-A	SO-0144	Between Rio and LFCC	High	34.000744	-106.870741	2.22	2.78	8.6	19.09	6 to 14
Brown Arroyo	BRN W-05-B	SO-0145	Between Rio and LFCC	High	34.000744	-106.870741	2.22	1.92	8.49	52.02	6 to 14
Escondida	ESC E-01-A	SO-0146	East of Rio	High	34.120358	-106.886393	1.88	1.39	9.69	20.49	8 to 12

Peizometer that share the same casing

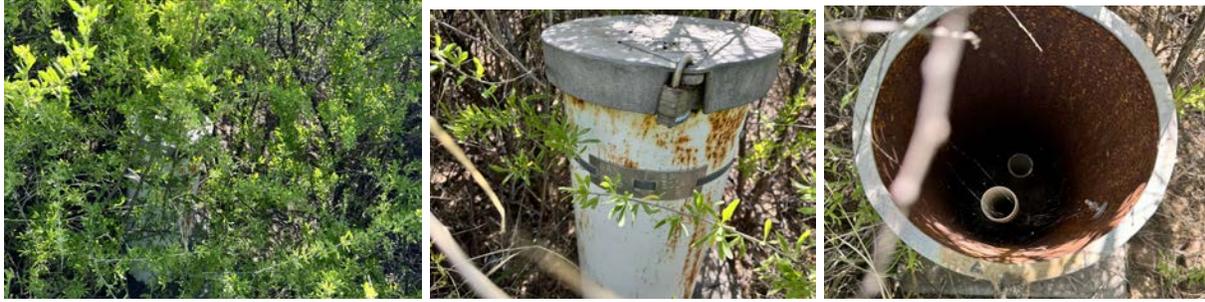
SO-0125 / BRN E-01-A (shallow)

Site conditions: Grazing, wildlife likely, Fire Ants

Site obstructions: Well is in dense foliage and will require clearing around the site before use

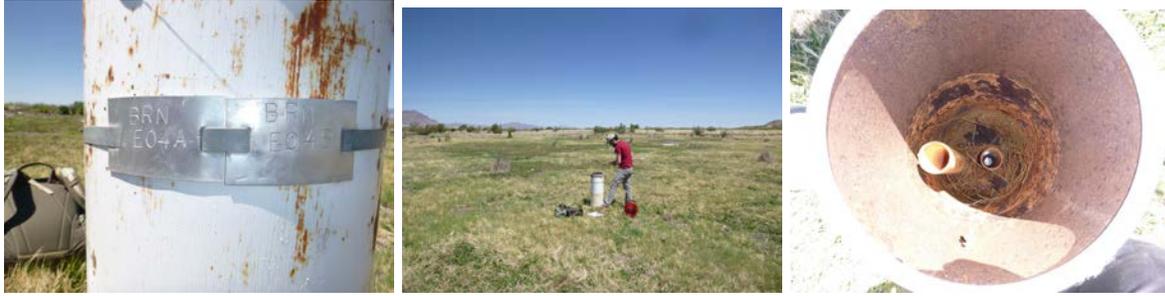
SO-0131 / BRN E-04-B (shallow)

Site conditions: Grazing, wildlife likely.

Site obstructions: None, no posts around well

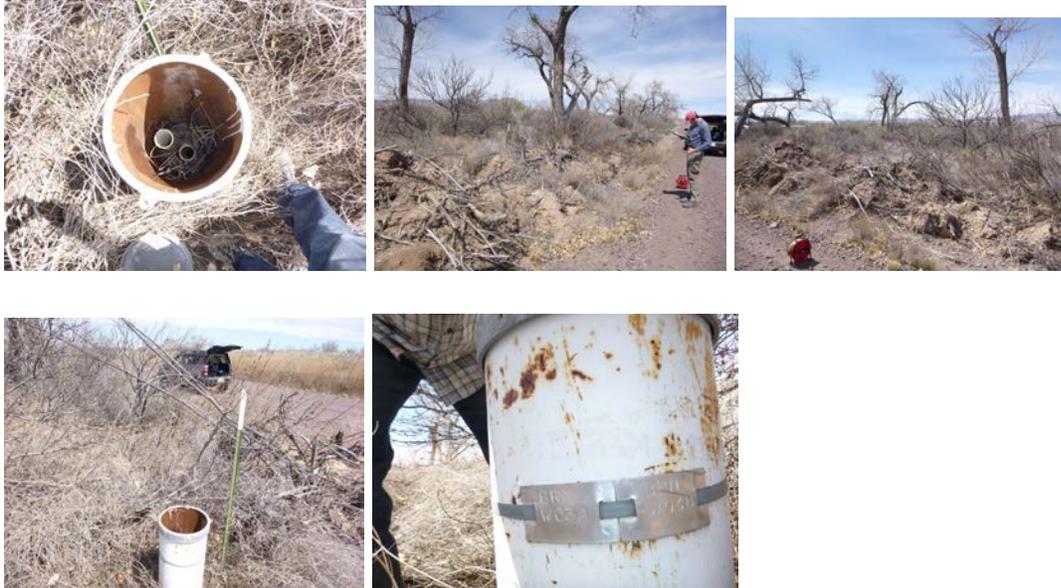
SO-0140 / BRN W-03-A

Site conditions: Casing accessible by road,

Access for vehicles: mostly hidden by scrub and debris; ground around the well is uneven.

Vandalism Risk: medium

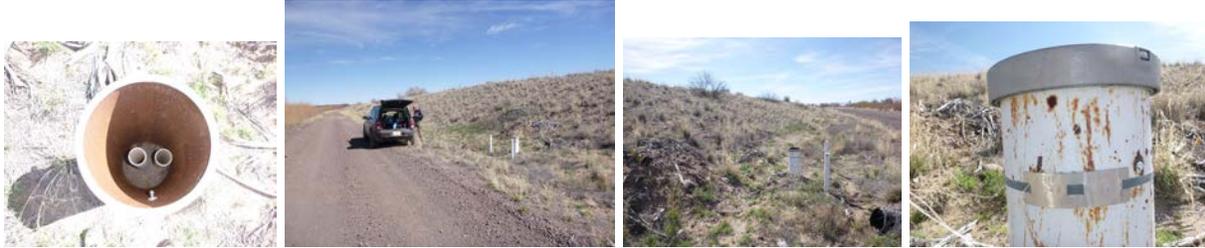
SO-0142 / BRN W-04-A

Site conditions: clear of debris, along ditch road

Well camera data: Top screened interval: 7.62 ft, Top water: 9.52, Well bottom: 21.62

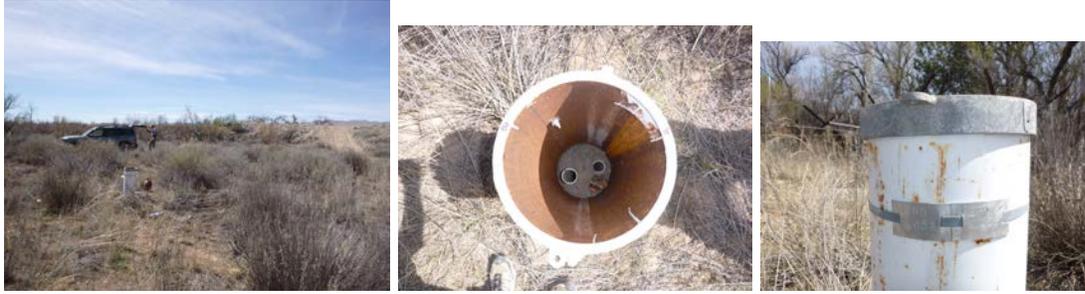
SO-0144 / BRN W-05-A (Shares the same outer casing as SO-0145 / BRN W-05B)

Access for vehicles:Well accessible by road on levee, not via picnic area as jetty jacks are between the picnic area and the well.

Equipment:Well is unequipped. Wellhead cannot support future equipment installation.

Well camera data: Top screened interval: 5.28 ft, Top water: 7.56 ft

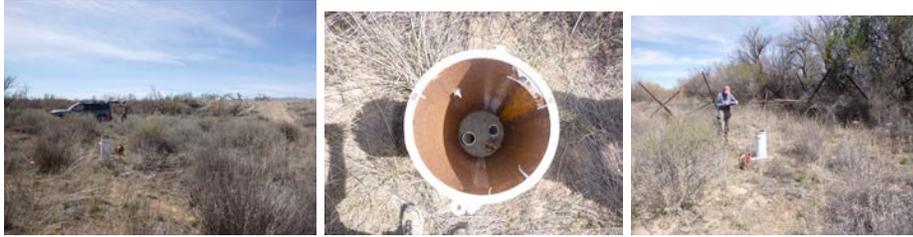
SO-0145 / BRN W-05-B (Shares the same outer casing as SO-0144 / BRN W-05A)

Access for vehicles: Well accessible from levee road, not from picnic area as jetty jacks are between picnic area and well.

Well camera data: Top water: 8.46 ft, Top screened interval: 48.02 ft, Bottom: 52.55

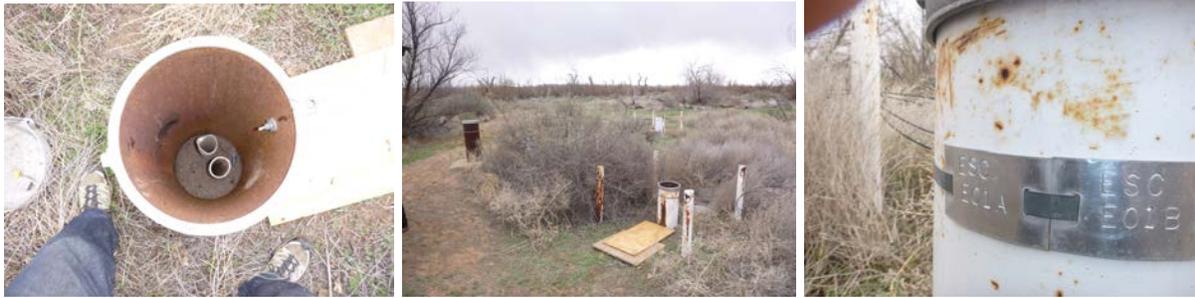
SO-0146 / ESC E-01-A

Site conditions:Next to a frequented recreation area next to the bridge. Key for casing.

Site obstructions: Well has posts surrounding it. Space to install equipment.

Vandalism Risk: high

Well camera data:top of screen casing 6.02' from side camera, top of screen slots 6.75' side camera, water 9.73', bottom 20.28

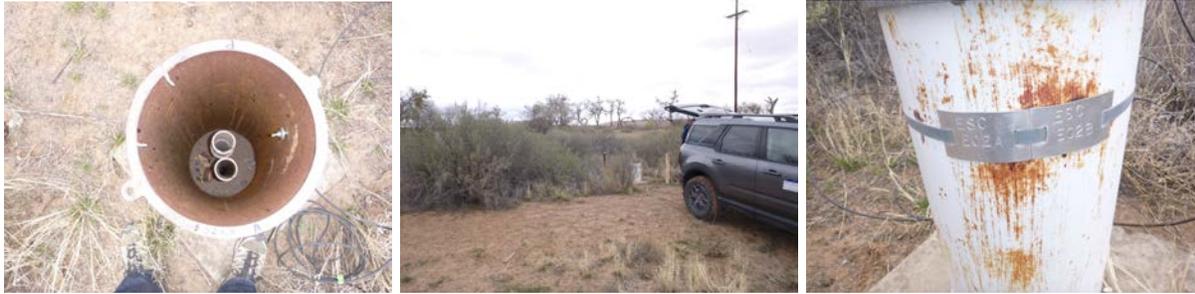
SO-0148 / ESC E-02-A

Site conditions: Next to heavily used "recreation area." key for casing.

Overhead obstructions:powerlines ~20' overhead but not obstructing

Site obstructions:Grown over vegetation.

Vandalism Risk:Pretty visible by the recreation area, high risk.

Well camera data: top of screen casing 6.41' from side camera, top of screen slots 6.81', water 10.55' from bottom camera

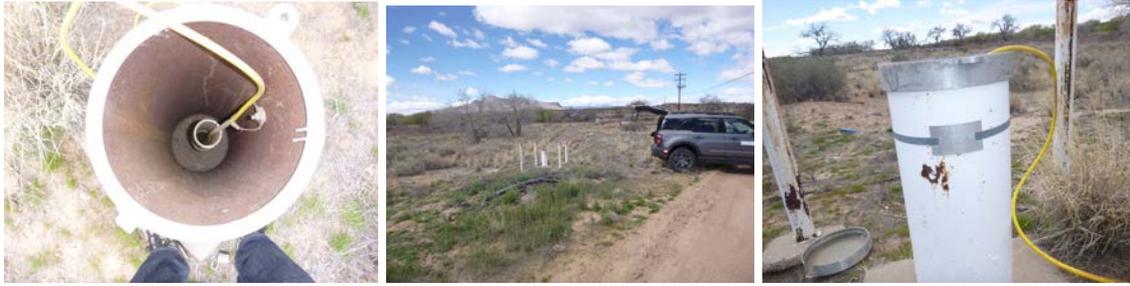
SO-0160 / ESC W-02-A

Site conditions:The well is easily viewed from the road.

Site obstructions: posts around well

Vandalism Risk:The site is a couple of hundred feet from a relatively busy road next to Escondida Lake (Pueblitos Rd). High

Well camera data: Well imagery:top of screen casing 6.18', water 10.48', bottom 20.77'
offset 0.86' (1.94' - 1.08' = 0.86') starting at 0.89'

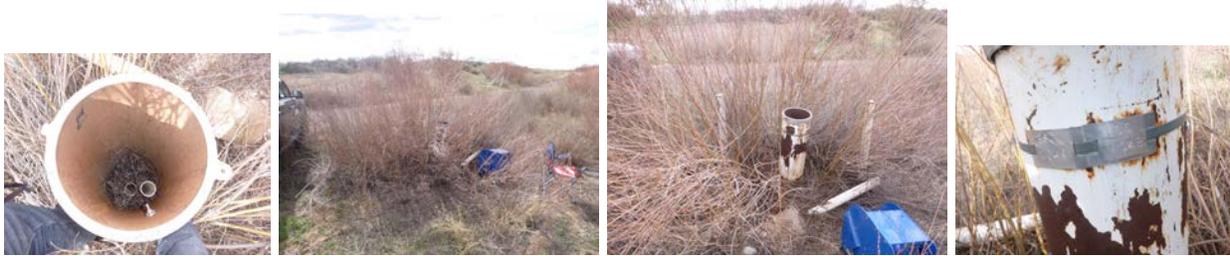
SO-0163 / ESC W-04-A

Site conditions: Well casing is grown over with vegetation. ~15' from road. Casing knocked over.

Site obstructions: Casing has posts around well, one post entirely knocked over.

Equipment: No, well is unequipped. No, wellhead will need repair before equipment can be installed.

Vandalism Risk: High vandalism risk.

Well camera data: Well bent, camera stuck 2.88'

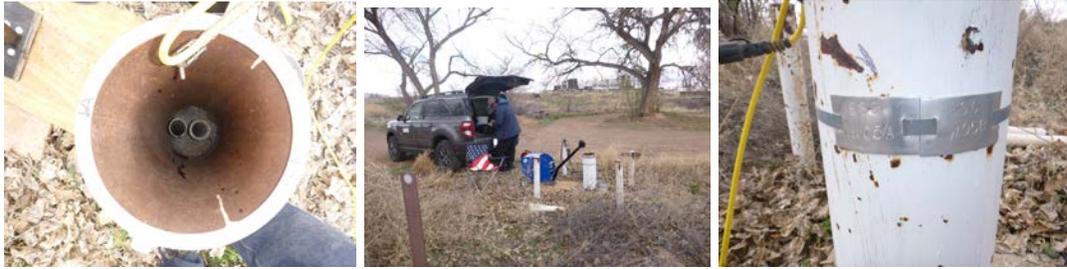
SO-0165 / ESC W-05-A (Shares the same outer casing as SO-0166 / ESC W-05B)

Site conditions: Right next to picnic table and fire ring, one of the posts is already down. Highly visible from Pueblitos rd. Vehicle access.

Equipment: Yes, well is currently equipped. Inner casing is broken, MP is below concrete pad level, may affect equipment potential.

Vandalism Risk: high

Well camera data: Top of screen slots - 5.42' with side cam, Water at 9.36'

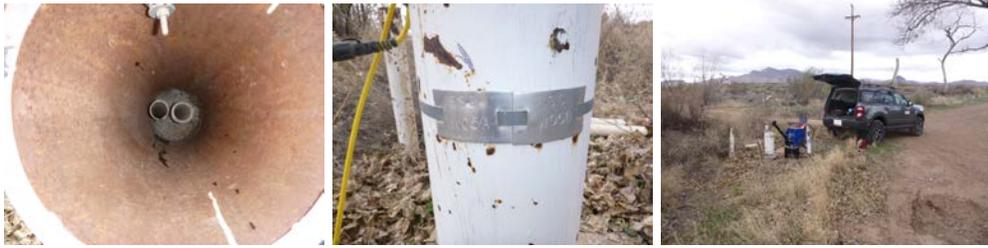
SO-0166 / ESC W-05-B-deep (Shares the same outer casing as SO-0165 / ESC W-05A)

Site conditions: Right next to picnic table and fire ring, one of the posts is already down. Highly visible from Pueblitos rd. Vehicle access.

Equipment:Yes, well is currently equipped. Inner casing is broken, MP is below concrete pad level, may affect equipment potential.

Vandalism Risk: high

Well camera data:Screen slot top: 48.9', Bottom 53'

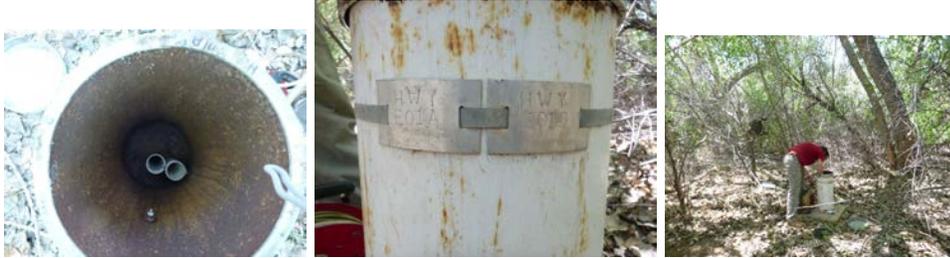
SO-0167/HWY E-01-A

Site conditions: A combo lock is needed to access the sites.

Overhead obstructions:Overhead vegetation.Overhead veg can be cleared easily.

Site obstructions:Maybe can cross river at clearing ~100yrds north from well. Be prepared to clear path with loppers.

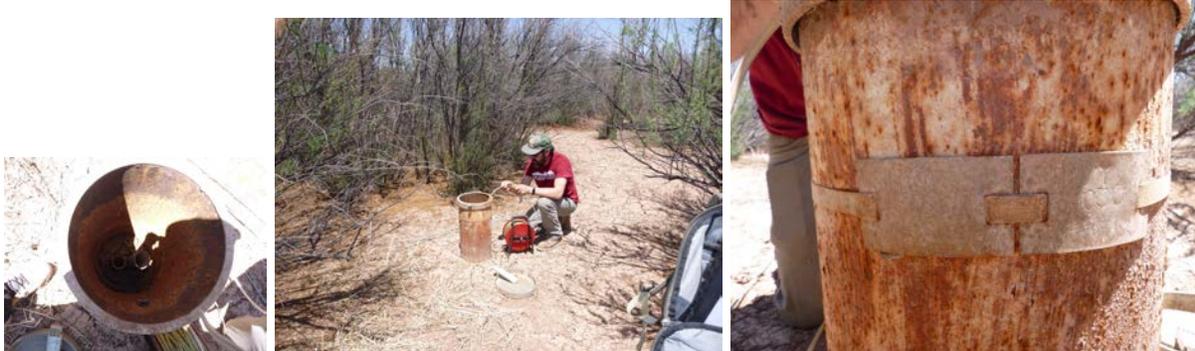
SO-0170 / HWY E-03-A

Site conditions: Drive through field until north of points, cross fence then ¼ mile south through salt cedar to well, light cattle trail.

Site obstructions: Potential flood risk, casing was white in old photo, now very rusted.

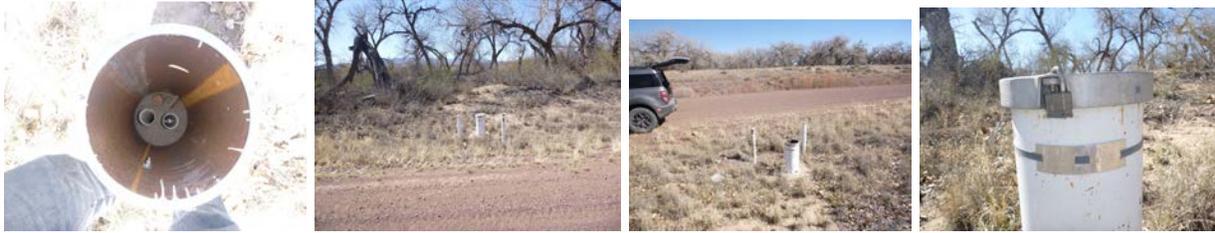
SO-0175/HWY W-04-A

Site conditions: Along LFCC access. Site in good condition with good access.

Vandalism Risk: Site is highly visible along LFCC, vandalism fairly high.

Well camera data: screens @ 5.5, water @ 8.14

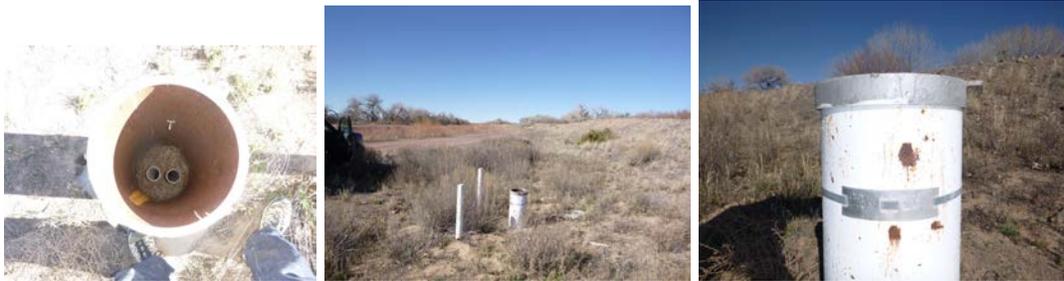
SO-0177 / HWY W-05-A

Vandalism Risk:highly visible from the LFCC road

Well camera data: screen at 5.25', water at 7.40', bottom at 12.2

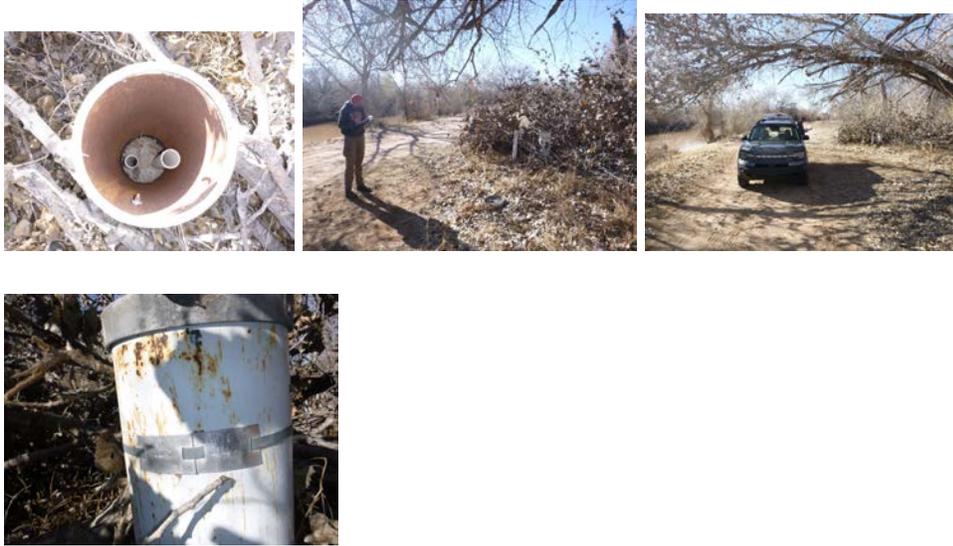
SO-0189 / HWY W-11-A (Shares the same outer casing as SO-0190 / HWY W-11B)

Overhead obstructions:Overhead vegetation.

Site obstructions:some woody debris around casing.

Well camera data:Top screened interval: 8.81 ft, Top water: 9.89 ft, Bottom well: 16.48ft

Equipment:No, well is unequipped. Need to clear tree debris around casing before installation.

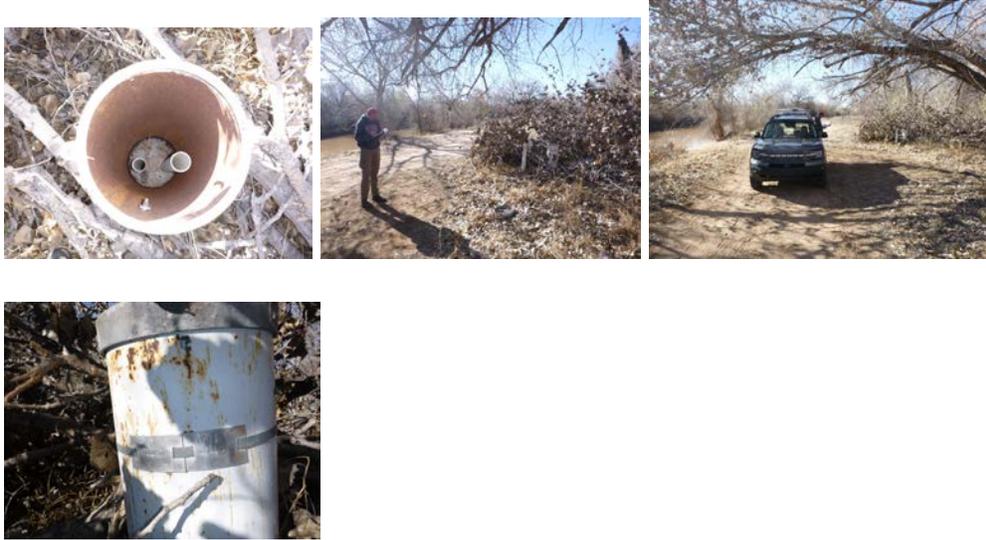
SO-0190 / HWY W-11-B (Shares the same outer casing as SO-0189 / HWY W-11A)

Overhead obstructions:Overhead vegetation.

Site obstructions:some woody debris around casing.

Well camera data: Water top: 9.52 ft, top screen: 51.23 ft, well bottom: 56.05.

Equipment:No, well is unequipped. Need to clear tree debris around casing before installation.

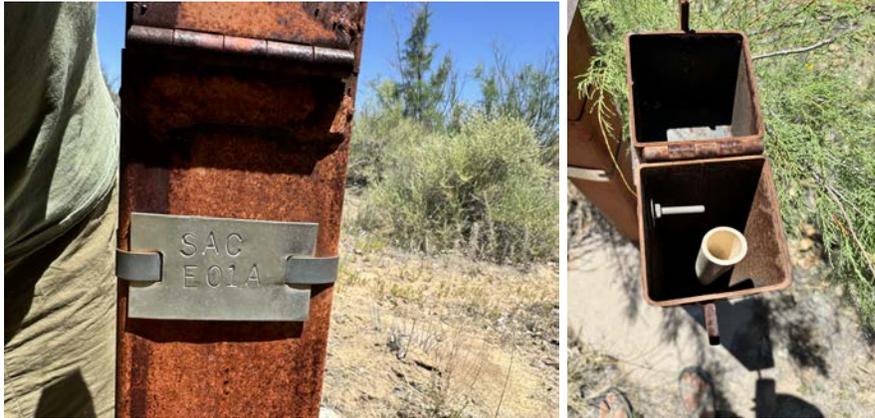
SO-0191 / SAC E-01-A

Well camera data: well too narrow to collect camera footage.

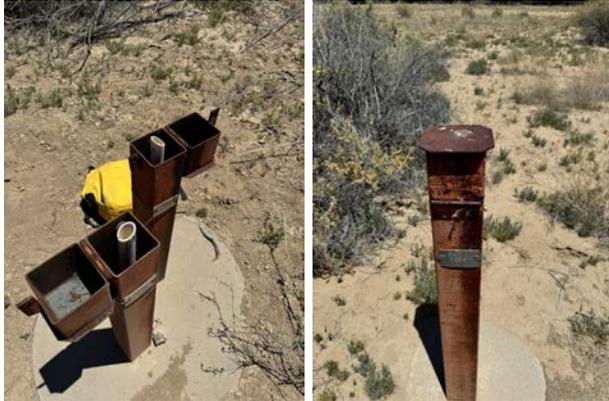
SO-0194 / SAC E-03-A

Site obstructions: near large burned area, well escaped the burn, lots of roots removed

Well camera data: well too narrow to facilitate camera, and very far from road

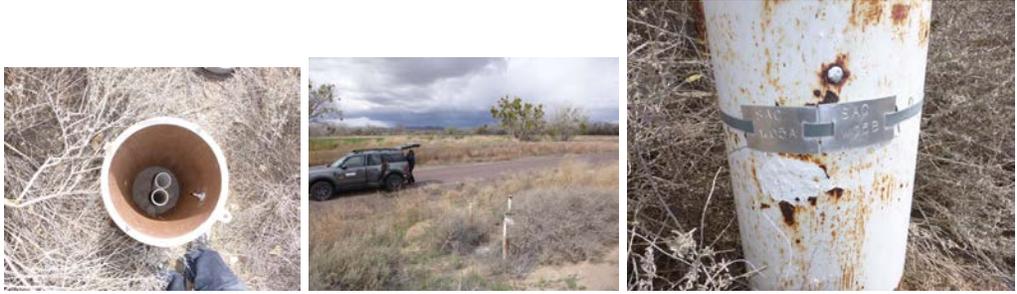
SO-0204 / SAC W-05-A

Well camera data: top of screen slots 8.92', water 16.24, bottom 22.74'

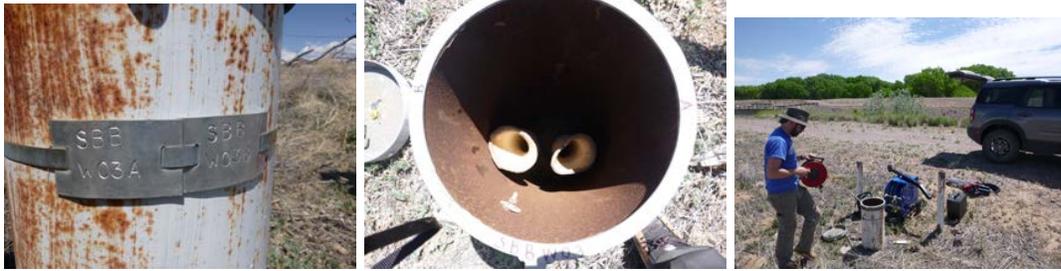
SO- 0223 / SBB W-03-A (Shares the same outer casing as SO-0224 / SBB W-03A)

Well camera data: No camera, PVC warped.

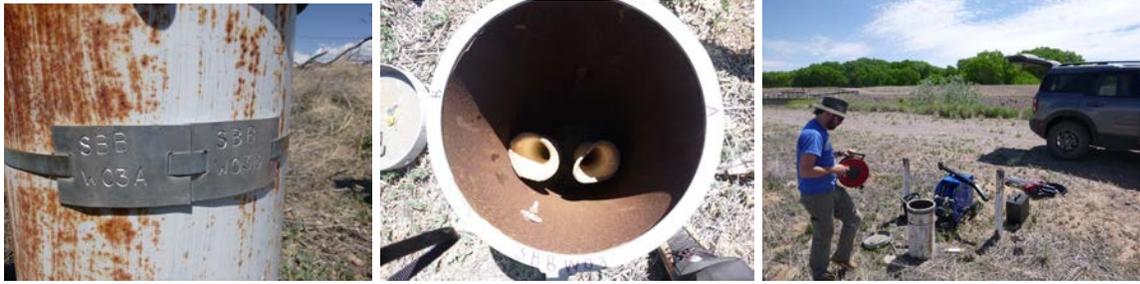
SO- 0224 / SBB W-03-B-deep (Shares the same outer casing as SO-0225 / SBB W-03B)

Well camera data: No camera, PVC warped.

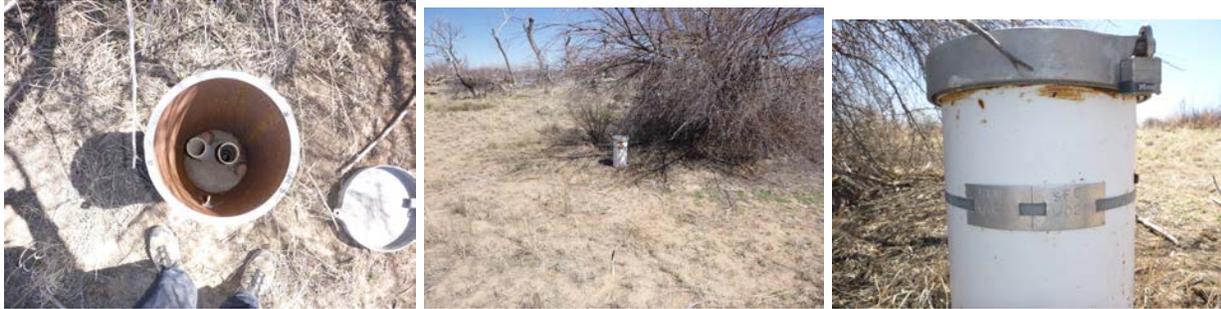
SO-0234 / SFC W-02-A

Site conditions: Someone is actively clearing salt cedar and has replowed road. Site is in burned out area, but wells look okay. Roots will be removed from well before installation.

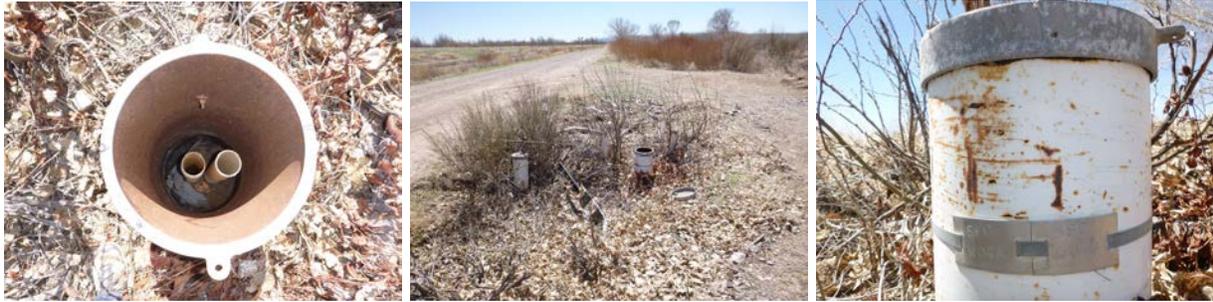
SO-0238 / SFC W-04-A

Site conditions: Site highly visible to people on the road. These wells are in a slight depression next to the road. No pipes surrounding wells for protection there are pipes just buried in mesquite.

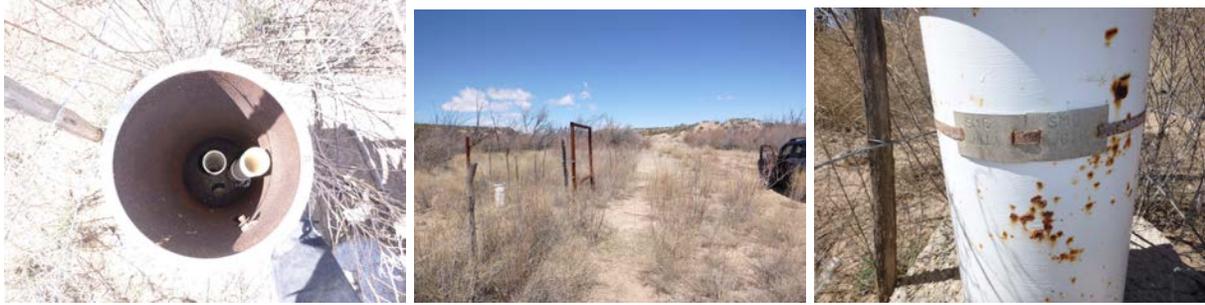
SO-0245 / SMC W-01-B

Site conditions: Access could be difficult/muddy on wet days, the site is in a lower elevation spot.

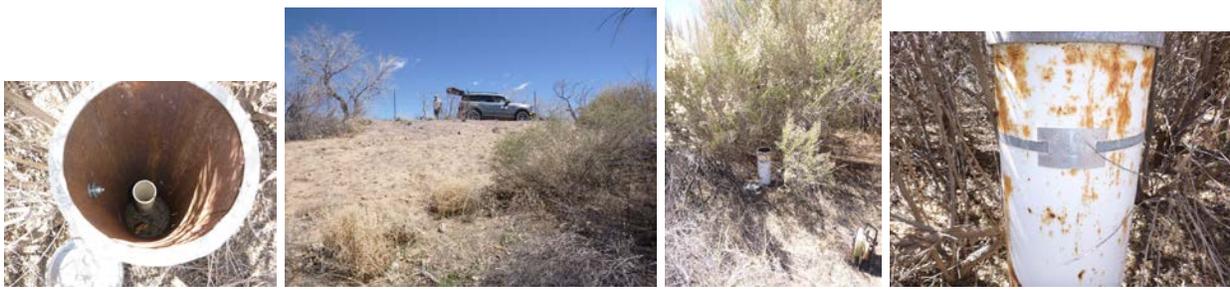
SO-0246 / SMC W-02-A

Site conditions: Site behind barbed wire, very overgrown (chamisa?) and hard to see. Have to crawl under fence, then about 20-30' feet downhill, Well needs to have roots removed,

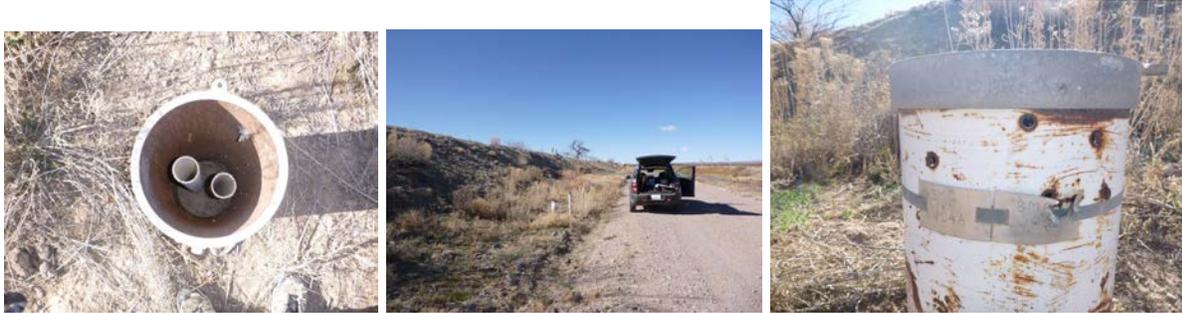
SO-0249 / SMC W-04-A (Shares the same outer casing as SO-0261 / SMC W-04B)

Equipment: No, well is unequipped. No, wellhead will need repair before equipment can be installed.

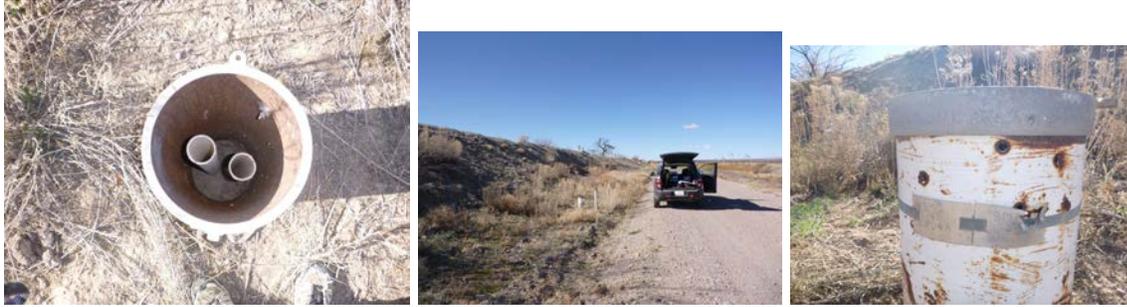
SO-0261 / SMC W-04-B (Shares the same outer casing as SO-0249 / SMC W-04A)

Equipment: No, well is unequipped. No, wellhead will need repair before equipment can be installed.

Well camera data: 8.15' water, 22.2' hit bottom No screens observed
