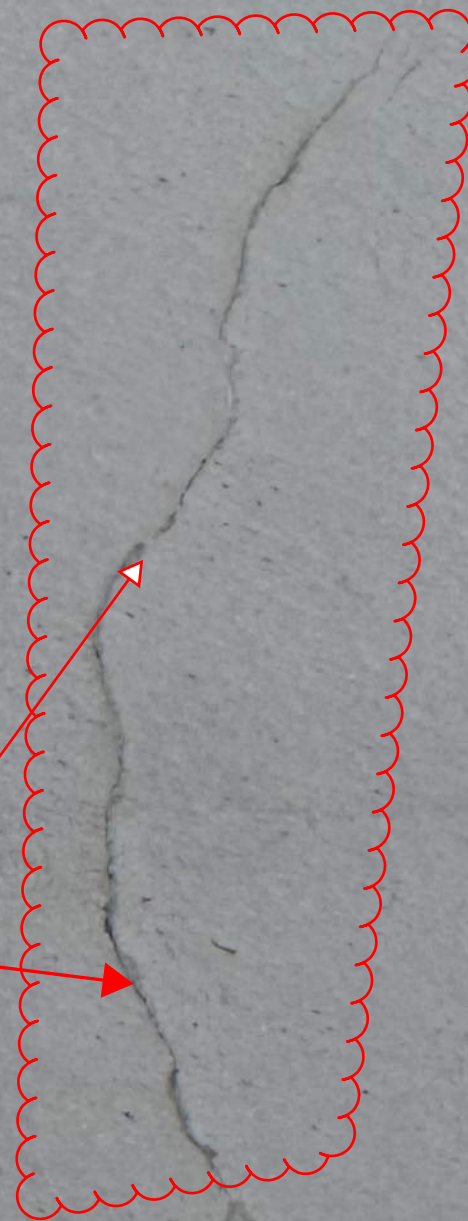
With Pool Drainage, numerous points of cracking witnessed, but one notable is at the transition to the deeper end of the pool is the bottom decking showing a 'spreading' motion of cracking

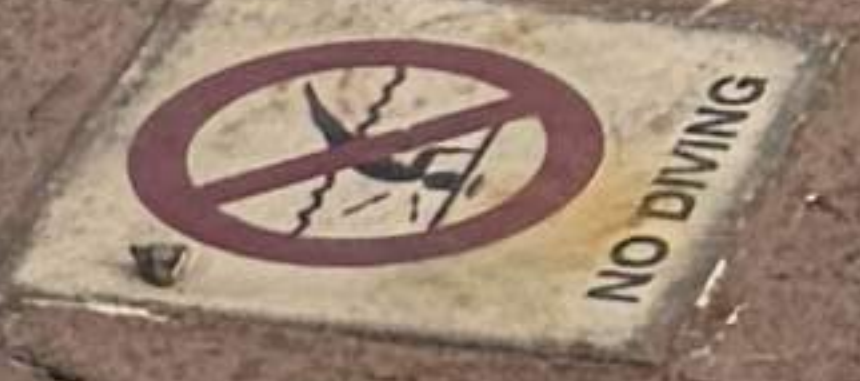
Previous Patching failure. Exposure to chlorinated water, and movement weakens patching and allowing water migration into the deck and compromise reinforcing steel

Patching Material bond held to deck, movement presenting after patch was made

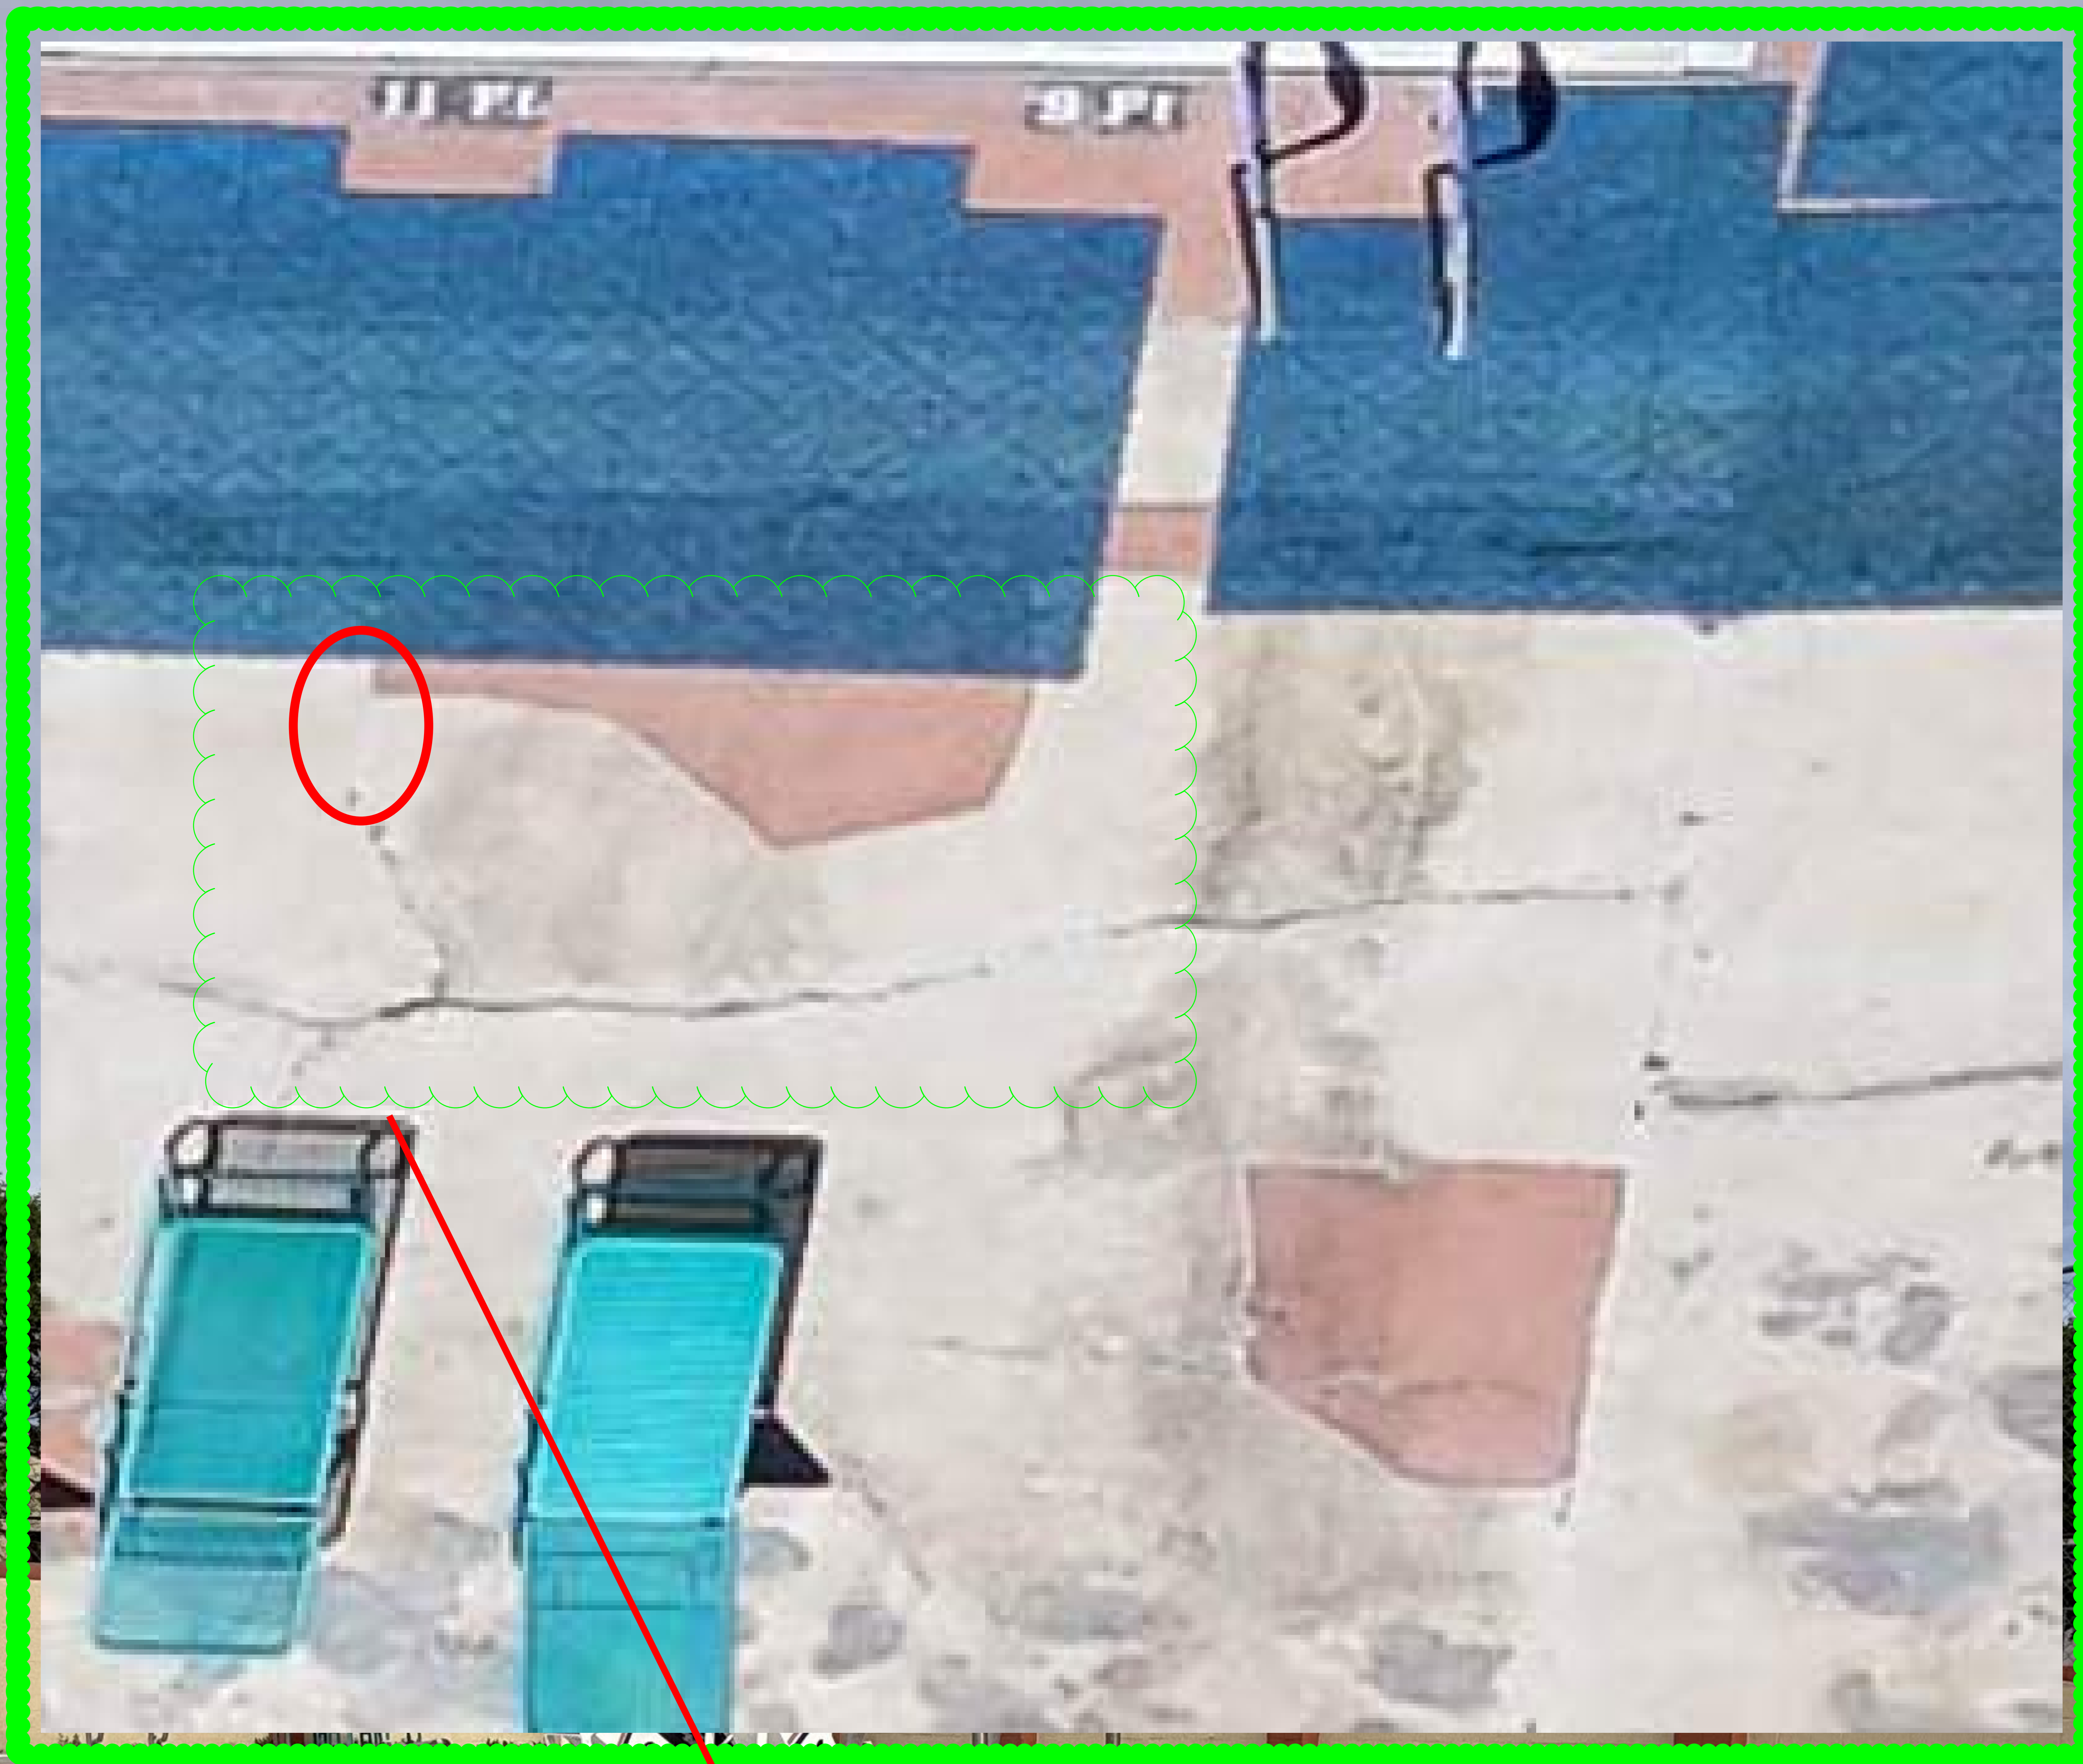
Continuous signs of movement in the decking at varying rates

Apparent growth in cracking on deck.

Aerial was taken 8/1/2025.
In person was taken 4/29/2026
