A-Core Detection Report

Project name: NM Tech Pool Customer: Franken
Location: Scan 1 Object: -
User: -
Comment: -

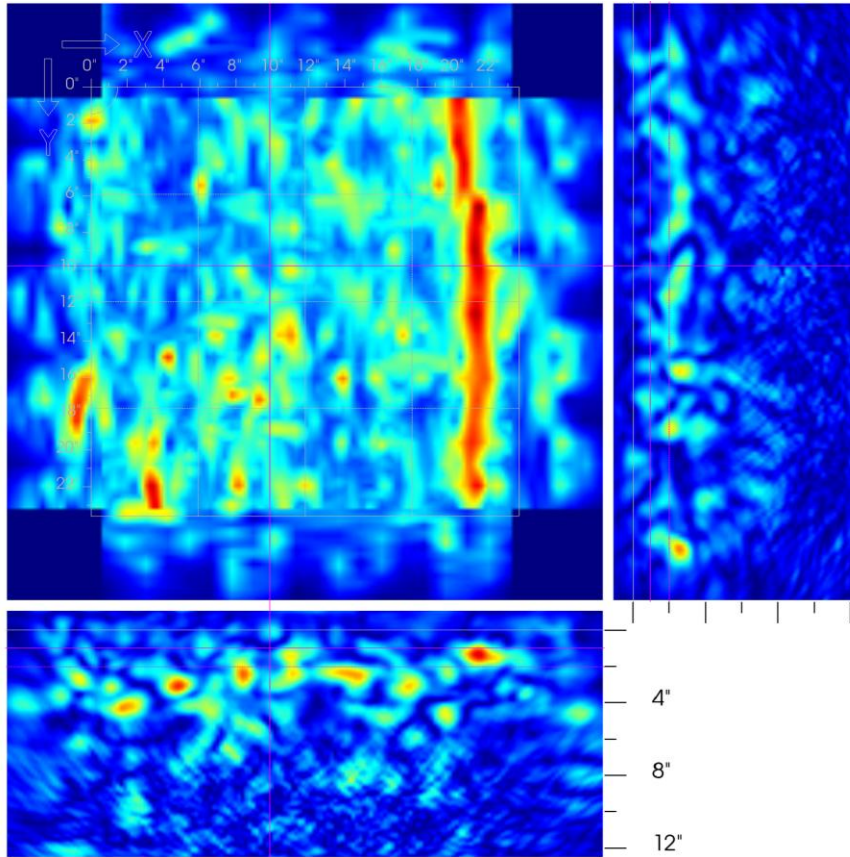
x: 9.8 in y: 9.8 in z: 1.0 in Thickness: 1.0 in
Overlay: - in Concrete: 9.0 Method: Advanced Cut-off: - in

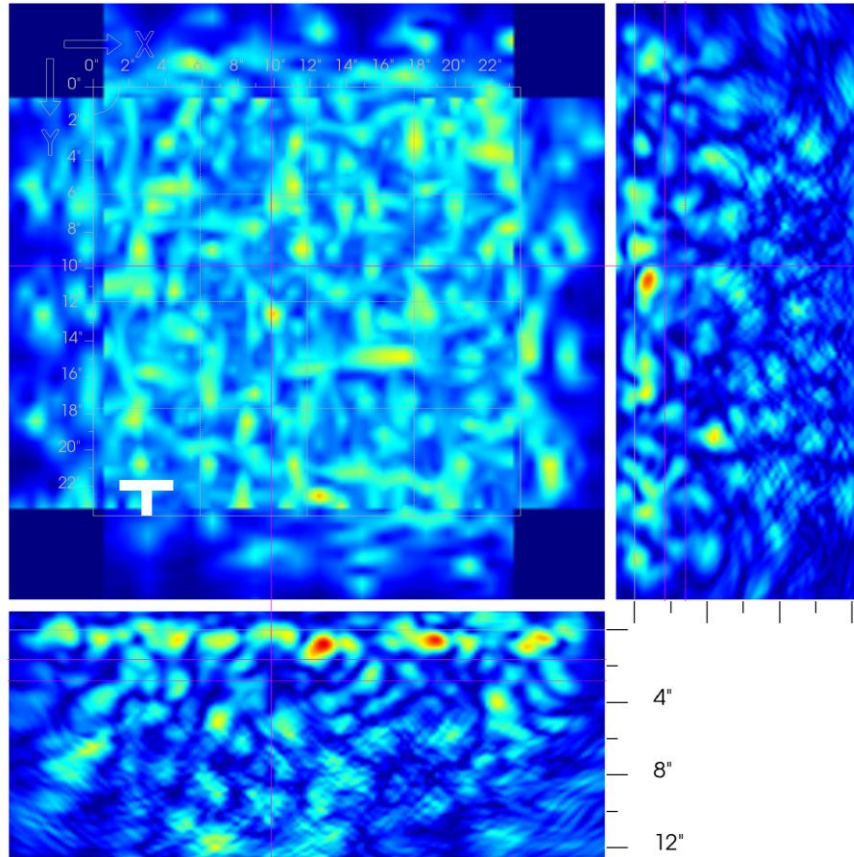
x: 9.8 in y: 9.8 in z: 1.7 in Thickness: 1.2 in
Overlay: - in Concrete: 9.0 Method: Advanced Cut-off: - in

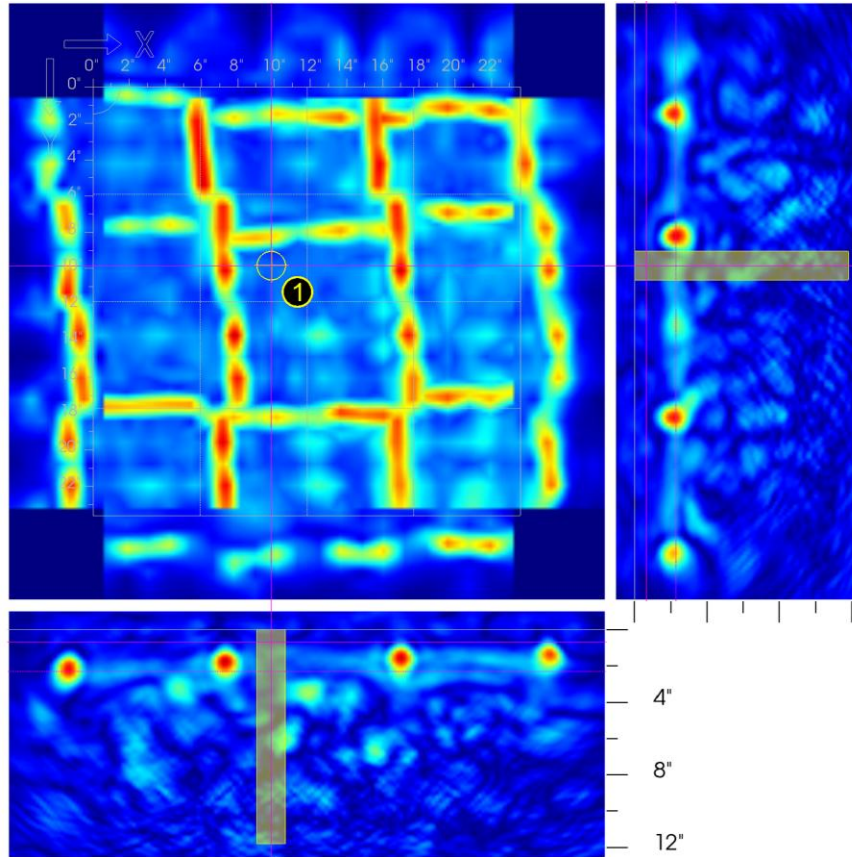
x: 9.8 in y: 9.8 in z: 0.7 in Thickness: 1.6 in
 Overlay: - in Concrete: 9.0 Method: Advanced Cut-off: - in

Drillholes:	x:	y:	Depth:	Diameter:	Comment:
1.	9.8 in	9.8 in	11.8 in	1.6 in	-

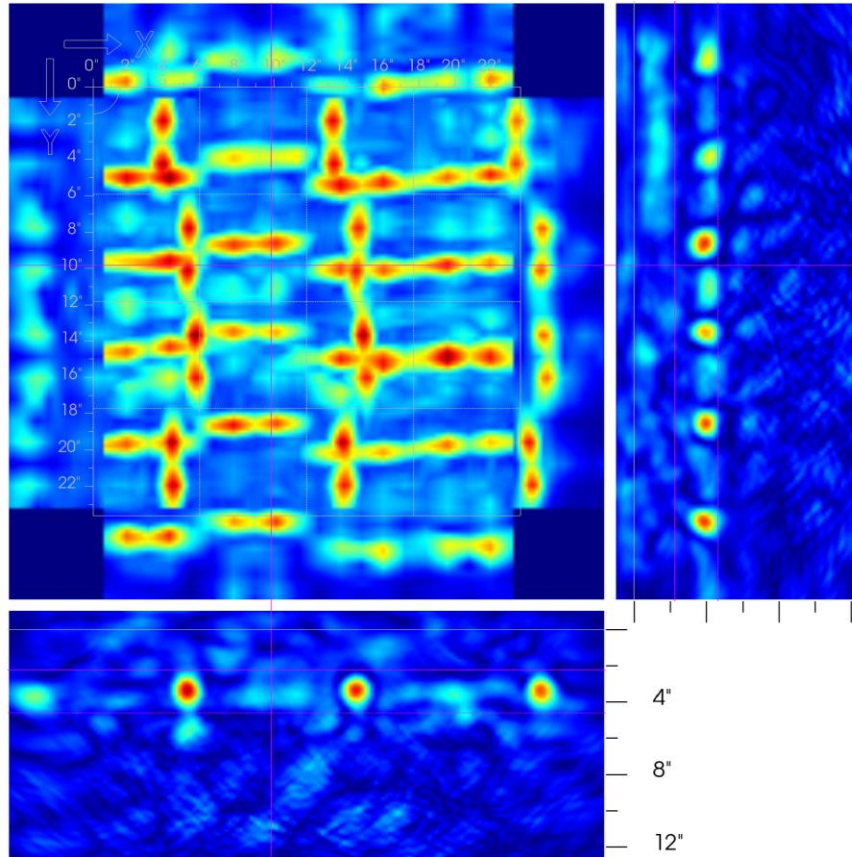
x: 9.8 in y: 9.8 in z: 2.2 in Thickness: 2.4 in
Overlay: - in Concrete: 9.0 Method: Advanced Cut-off: - in

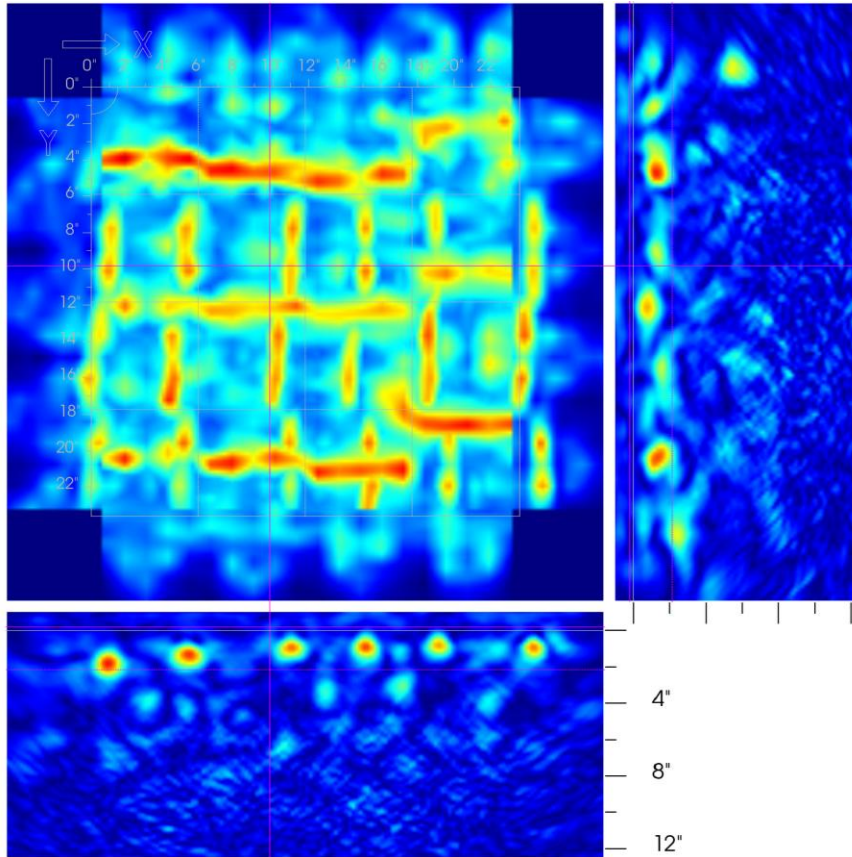
x: 9.8 in y: 9.8 in z: -0.2 in Thickness: 2.4 in
Overlay: - in Concrete: 9.0 Method: Advanced Cut-off: - in
