## Ground penetrating radar (GPR) data from NMT pool collected April 9, 2026

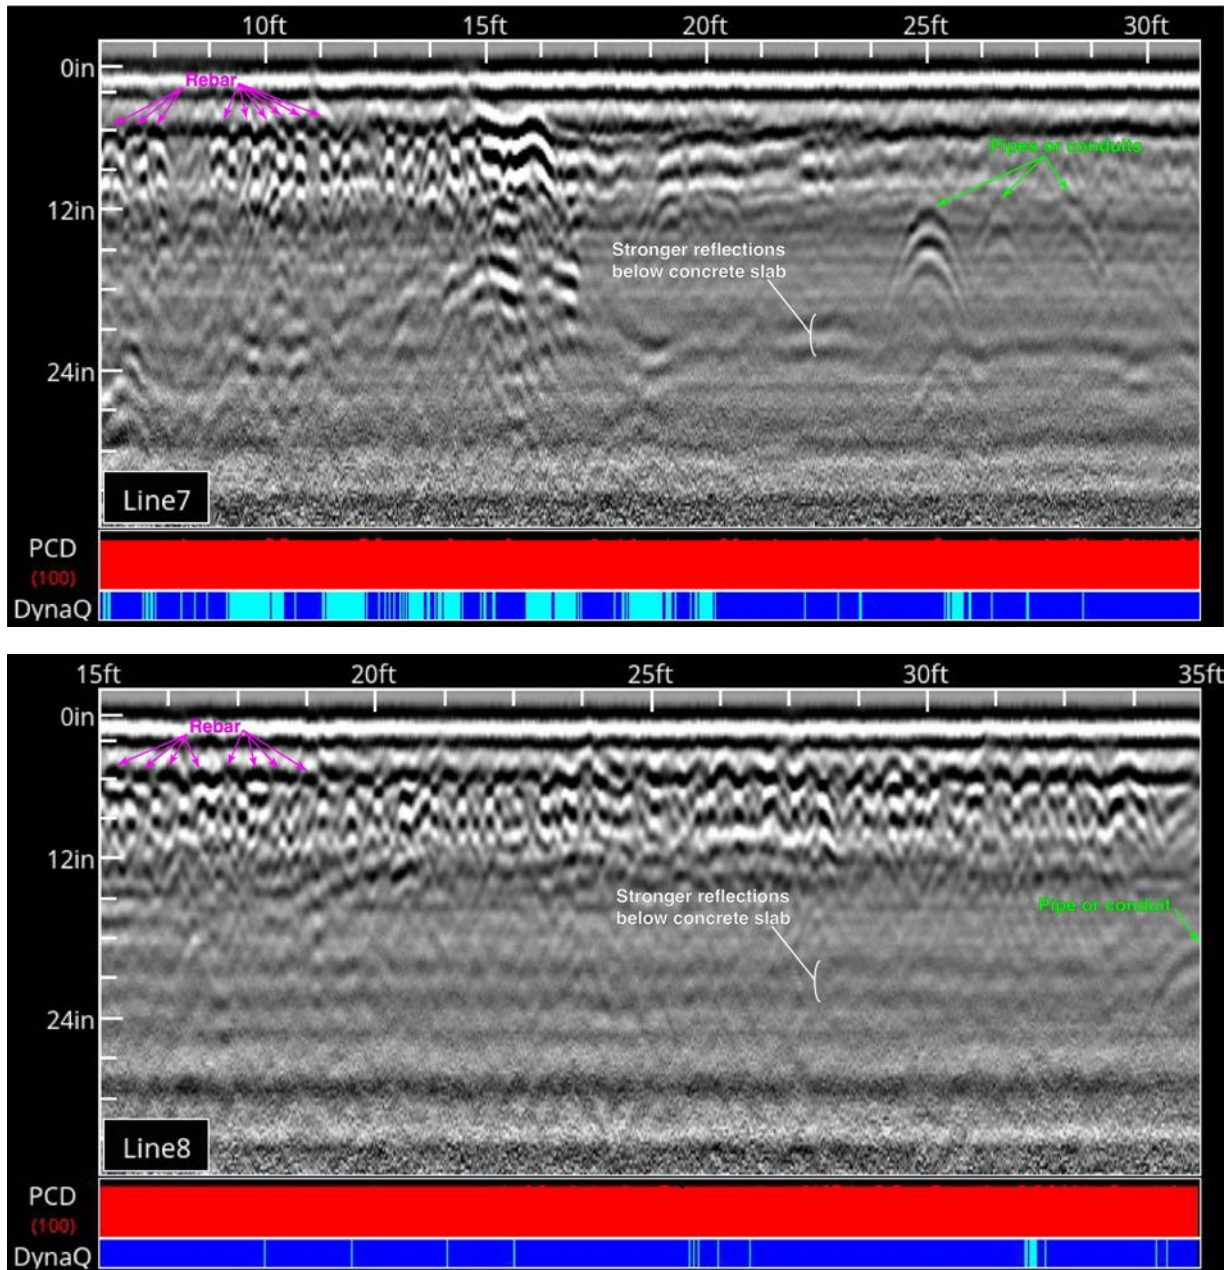
Figure 2: Lines 7 (top) and 8 (bottom) on the pool deck near the southwest corner of the pool. The west end of the lines is to the left. There are some stronger reflections at ~20" depth. These appear more prominent in Line 7 from ~17-31'. This coincides with a portion of Line 7 in which rebar appears to be absent from the concrete slab; in contrast, rebar is present continuously throughout Line 8. The more easily identified stronger reflections at depth in Line 7 in the area without rebar in the slab may simply be due to less attenuation/noise in the GPR data at depth in the section without rebar. Overall, the stronger reflections at depth may result from moisture below the slab.

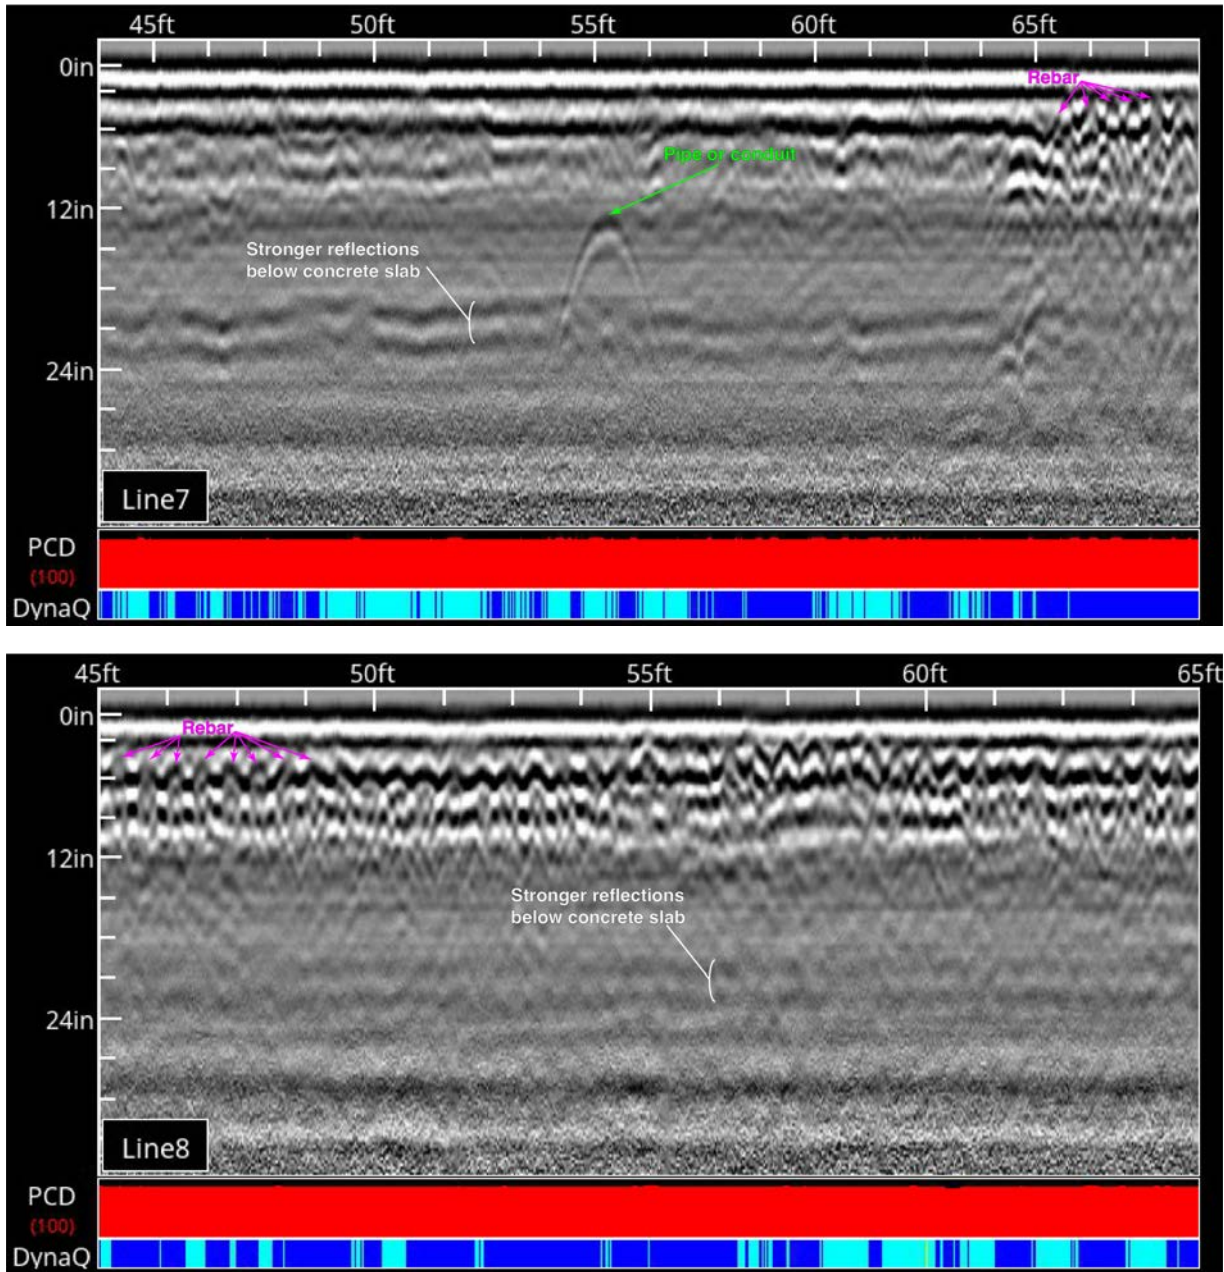
Figure 3: Lines 7 (top) and 8 (bottom) on the pool deck near the southeast corner of the pool. The west end of the lines is to the left. There are some stronger reflections at ~20" depth. These appear more prominent in Line 7 from ~44-64', coinciding with a portion of Line 7 in which rebar appears to be absent from the concrete slab. Rebar is present continuously throughout Line 8. The more easily identified stronger reflections at depth in Line 7 in the area without rebar in the slab may be due to less attenuation/noise in the GPR data at depth in the section without rebar. Similar to the findings in 2025, the stronger reflections at depth may result from moisture below the slab.

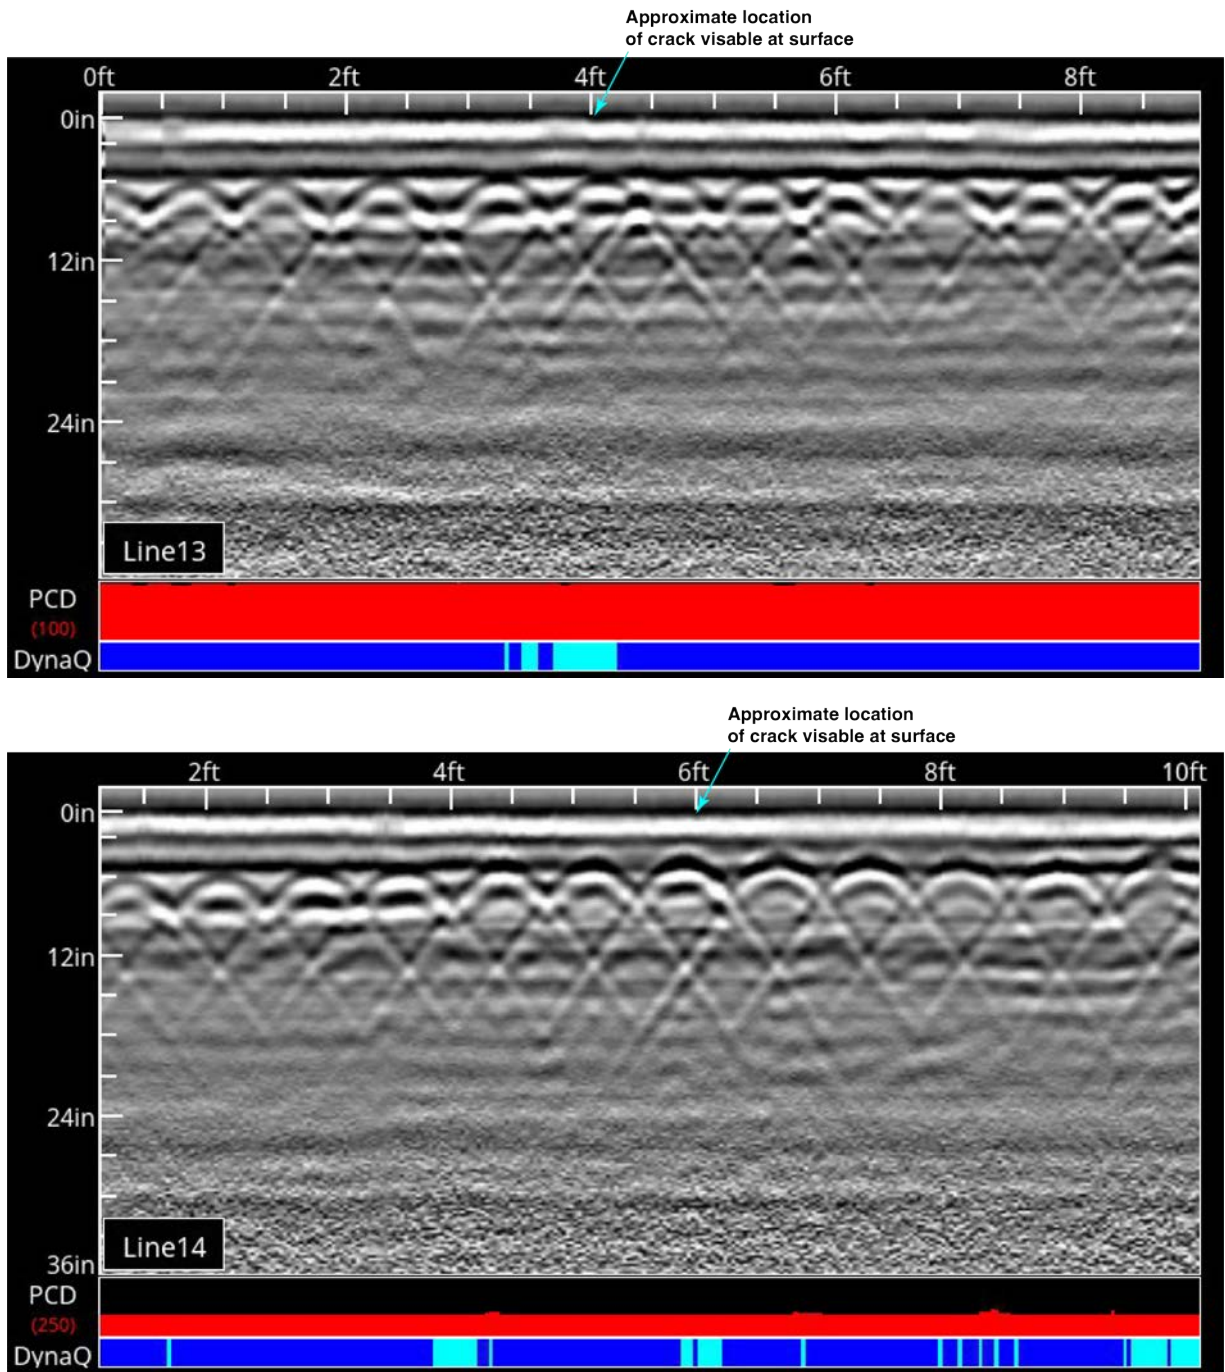
*Crossing the crack on the west side of the pool – Lines 13 and 14*

Figure 4: Lines 13 (top) and 14 (bottom) in the pool, crossing the crack on the west side of the pool. The north end of the lines is to the left. No substantial anomalies are apparent below the location of this crack at the surface or in the vicinity around it.

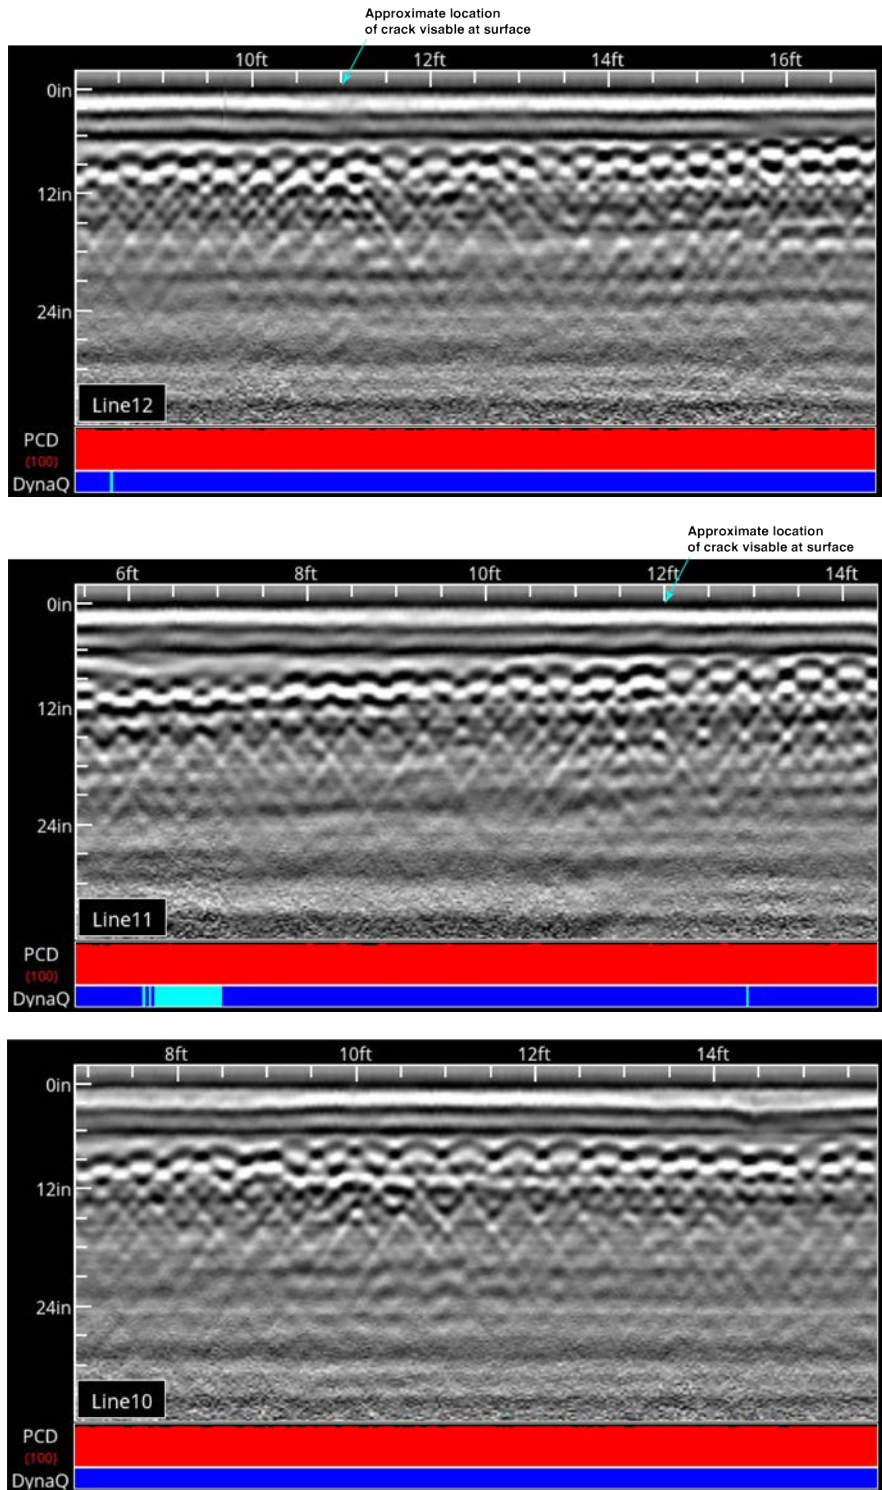
*Near and crossing the crack on the east side of the pool – Lines 10, 11, and 12*

Figure 5: Lines 12 (top), 11 (center), and 10 (bottom) in the pool. The south end of the lines is to the left. Lines 12 and 11 cross the crack on the east side of the pool. The crack does not extend to Line 10. There are no clear differences between the lines crossing the crack (Lines 12 and 11) and the parallel line that does not cross the crack (Line 10).

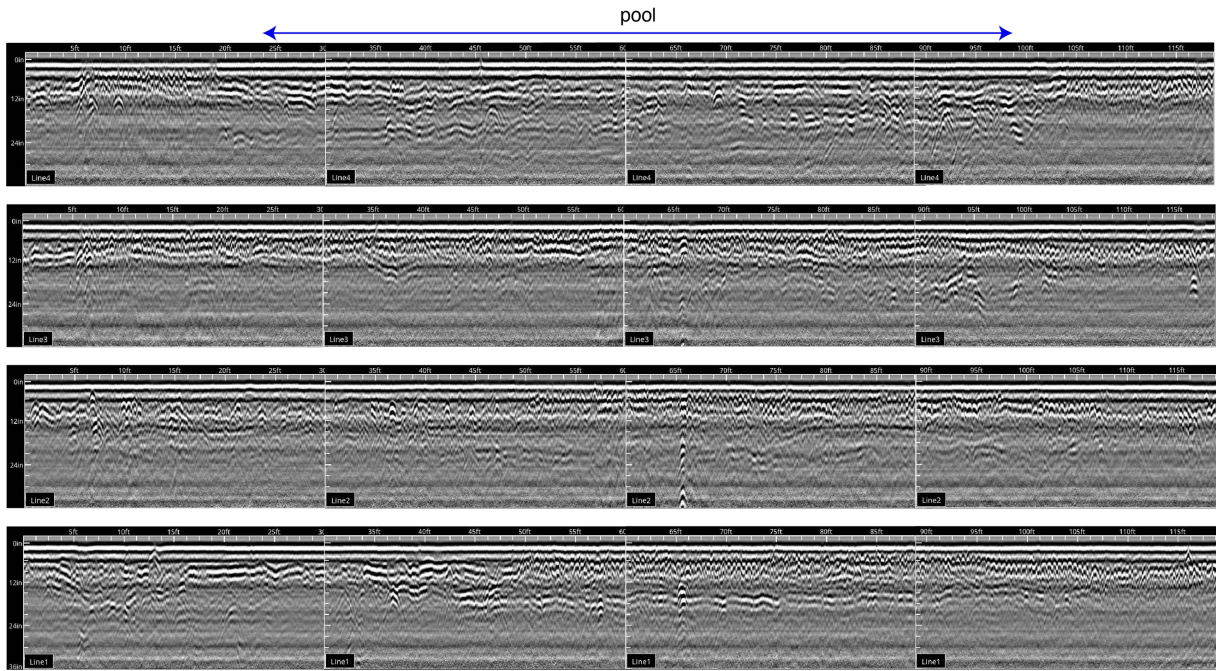
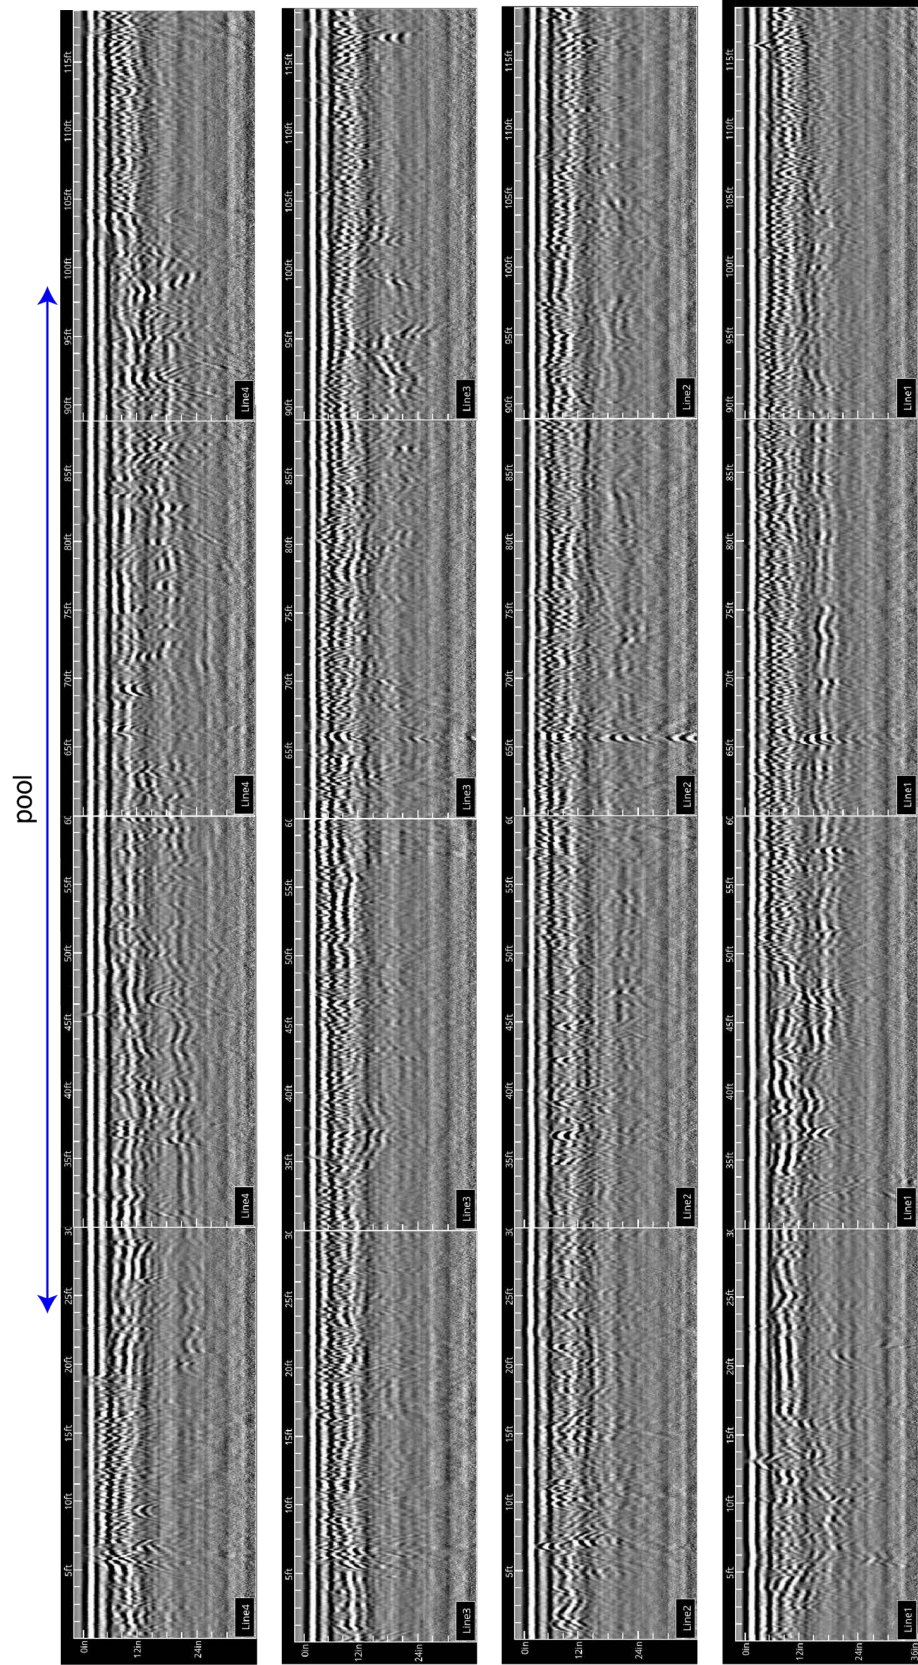
*Deck east of the pool – Lines 1 through 4*

Figure 6: Lines 4 (top; closest to pool) through line 1 (bottom; farthest from pool) on the deck on the east side of the pool. The south end of the lines is to the left. Lines 2 and 3 are on opposite sides of the attachment points for the pool bubble (Line 2 slightly to the east; Line 3 slightly to the west). The portion of the pool deck with notable subsidence is north of the end of the pool (i.e., at locations >100' along these profiles; the lines end at ~118'). There are no substantial anomalies apparent in or below the slab in the subsiding area (~100-118') relative to other locations. The most prominent strong reflections at depth below the slab are in line with the pool (i.e., not north of the pool) in Line 4 (~30-100'), Line 3 (~80-100'), Line 1 (~42-107'). The strongest of these deeper reflections is in Line 1 (farthest from the pool). A larger, rotated image of these profiles is on the next page (a digital version is available on the Google Drive).
