Transect	Well name ISC	Well ID	Location	Priority	Latitude	Longitude	Height of outer casing (up) - ft	Difference in height between outcasing and inner casing	Depth to Water (ft BTOC)	Total Depth (ft BTOC)	Expected water level fluctuations (ft bgs)
Brown Arroyo	BRN E-01-A	SO-0125	East of Rio	High	34.003032	-106.869709	2.2	0.82	5.7	20.1	2 to 13
Brown Arroyo	BRN E-04-A	SO-0131	East of Rio	High	34.003714	-106.860987	2.35	0.94	2.66	16.92	1 to 6
Brown Arroyo	BRN W-03-A	SO-0140	West of LFCC	High	34.00067	-106.872017	2.24	1.56	12.18	19.91	10 to 14
Brown Arroyo	BRN W-04-A	SO-0142	West of LFCC	Low	34.000651	-106.871465	2.19	1.02	9.5	22.15	8 to 11
Brown Arroyo	BRN W-05-A	SO-0144	Between Rio and LFCC	High	34.000744	-106.870741	2.22	2.78	8.6	19.09	6 to 14
Brown Arroyo	BRN W-05-B	SO-0145	Between Rio and LFCC	High	34.000744	-106.870741	2.22	1.92	8.49	52.02	6 to 14
Escondida	ESC E-01-A	SO-0146	East of Rio	High	34.120358	-106.886393	1.88	1.39	9.69	20.49	8 to 12

Peizometer that share the same casing

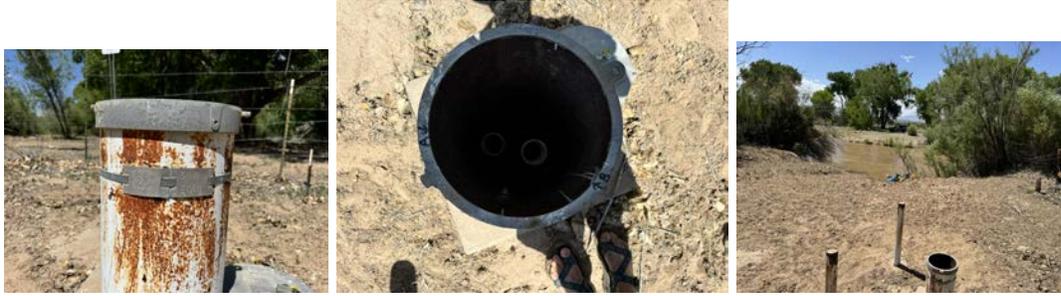
SO-0213 / SBB E-01-A

Height of outer casing (up)	Difference in height between outcasing and inner casing (down)	DTW (ft BTOC)	TD (ft BTOC)	Annual Range of Water Levels (ft)
1.73	1.08	12.11	17.0	6 to 16

Site conditions: Grazing, wildlife likely

Well camera data: no, unable to transport camera across river.

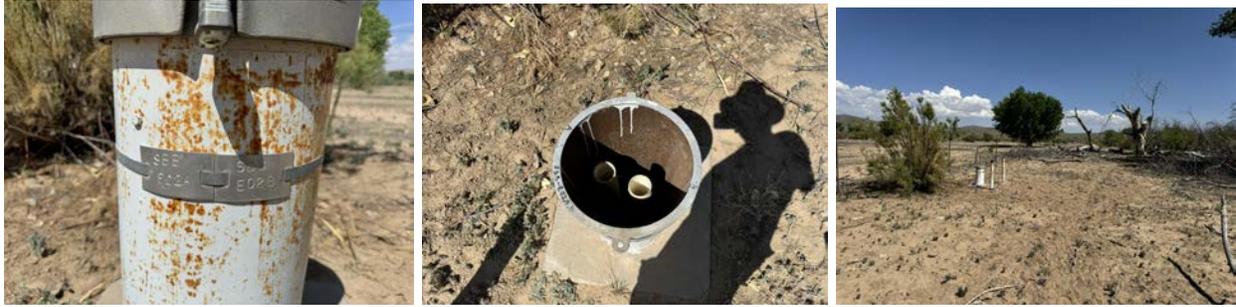
SO-0215 / SBB E-02-A

Height of outer casing (up)	Difference in height between outcasing and inner casing (down)	DTW (ft BTOC)	TD (ft BTOC)	Annual Range of Water Levels (ft)
1.68	0.66	13.15	21.55	8 to 16

Site conditions: Grazing, wildlife likely

Well camera data: no, unable to transport camera across river.

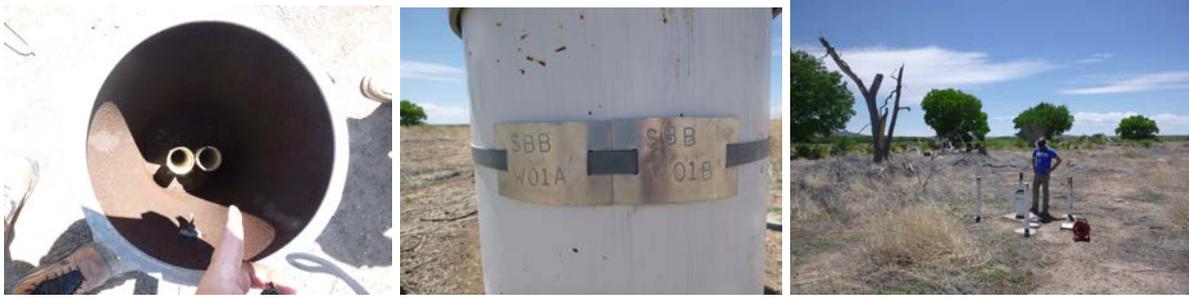
SO-0219 / SBB W-01-A

Height of outer casing (up)	Difference in height between outcasing and inner casing (down)	DTW (ft BTOC)	TD (ft BTOC)	Annual Range of Water Levels (ft)
1.74	1.32	4.88	20.13	3 to 7

Site conditions: 1/3 mile from ditch road.

Well camera data: No camera.

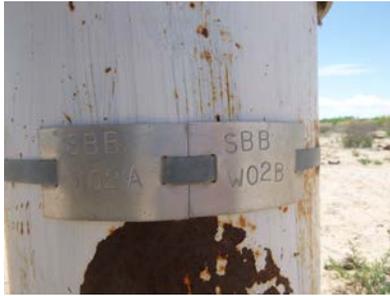
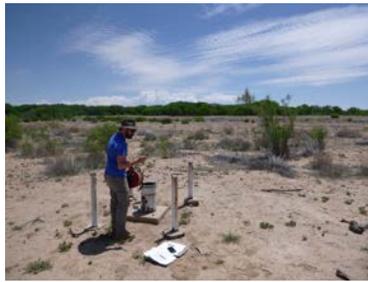
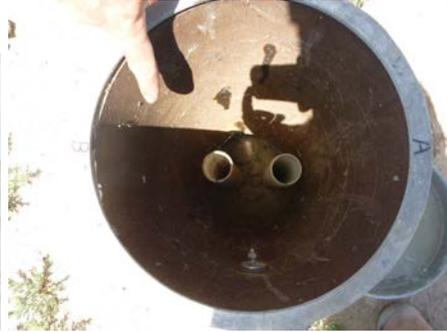
SO-0221 / SBB W-02-B (shallow)

Height of outer casing (up)	Difference in height between outcasing and inner casing (down)	DTW (ft BTOC)	TD (ft BTOC)	Annual Range of Water Levels (ft)
1.57	1.22	8.54	18.13	5 to 11

Site conditions: ~200 yards from ditch road.

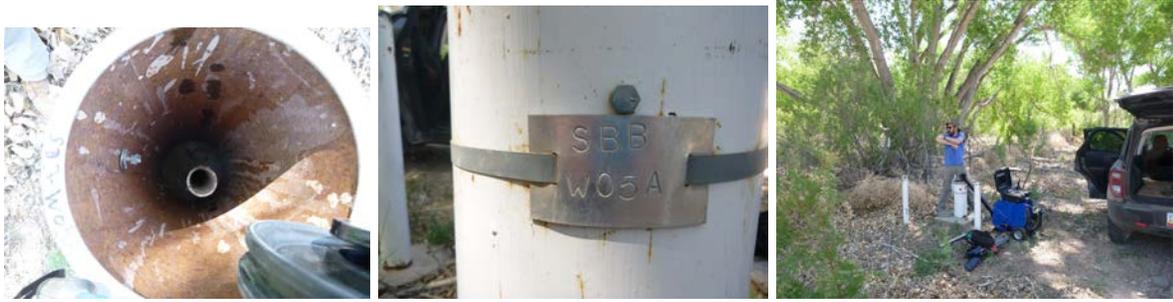
SO-0226 / SBB W-05-A

Height of outer casing (up)	Difference in height between outcasing and inner casing (down)	DTW (ft BTOC)	TD (ft BTOC)	Annual Range of Water Levels (ft)
2.01	1.15	12.66	20.40	9 to 17

Site conditions: Amendaris ranch. Gate code 5456.

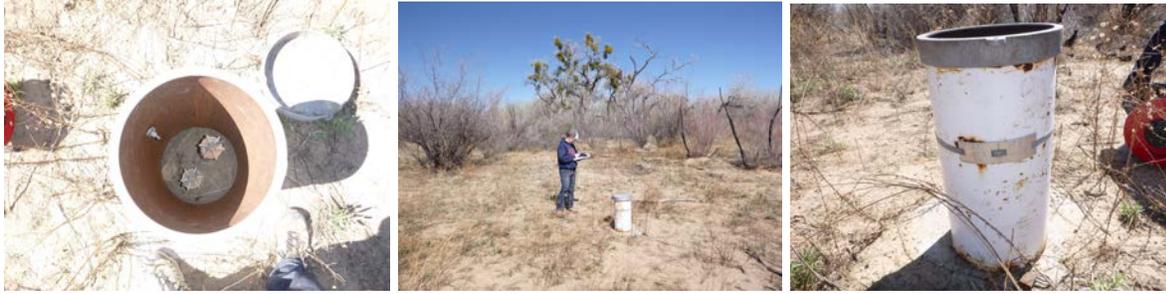
SO-0236 / SFC W-03-A

Height of outer casing (up)	Difference in height between outcasing and inner casing (down)	DTW (ft BTOC)	TD (ft BTOC)	Annual Range of Water Levels (ft)
1.83	1.09	5.65	19.57	2 to 8

Site conditions: Use newly graded access road, then walk. Site is generally open, located about 50 yds off side access road.

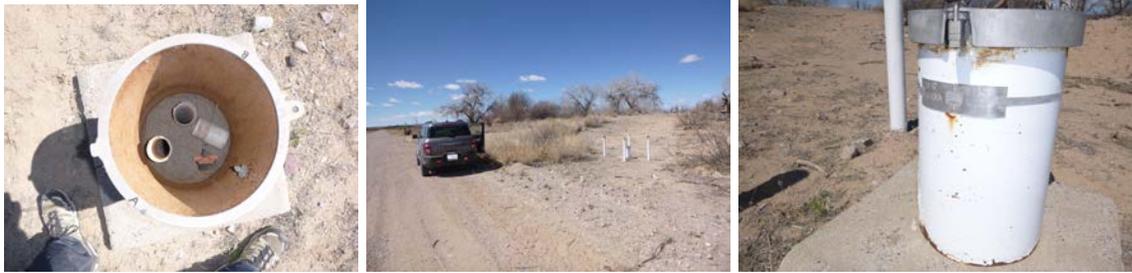
SO-0247 / SMC W-03-A

Height of outer casing (up)	Difference in height between outcasing and inner casing (down)	DTW (ft BTOC)	TD (ft BTOC)	Annual Range of Water Levels (ft)
1.45	0.81	10.74	20.25	8 to 12

Site conditions: Site easily viewable from road. Along open road. Key for outer casing.

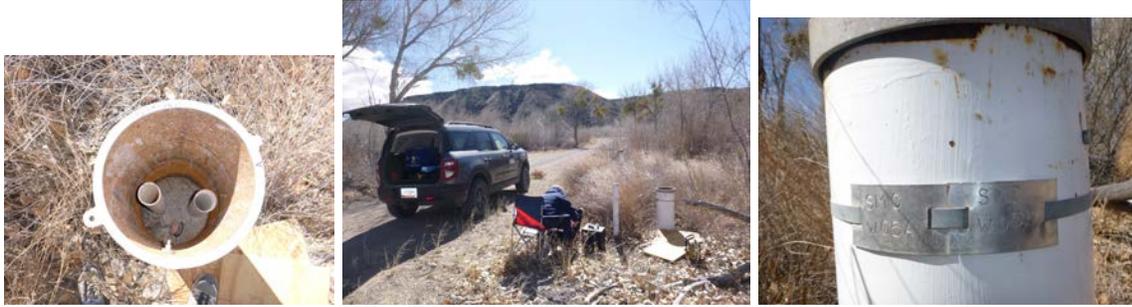
SO-0250 / SMC W-05-A

Height of outer casing (up)	Difference in height between outcasing and inner casing (down)	DTW (ft BTOC)	TD (ft BTOC)	Annual Range of Water Levels (ft)
2.29	0.84	10.84	20	6 to 13

Site conditions: Access is clear and easy.

Equipment: No, well is unequipped. No, wellhead will need repair before equipment can be installed.

Vandalism Risk: seems low but the casing has bullet holes in it so it's high

Well camera data: 8.15' water, 22.2' hit bottom No screens observed
