## Ground penetrating radar (GPR) data from NMT pool collected April 9, 2026

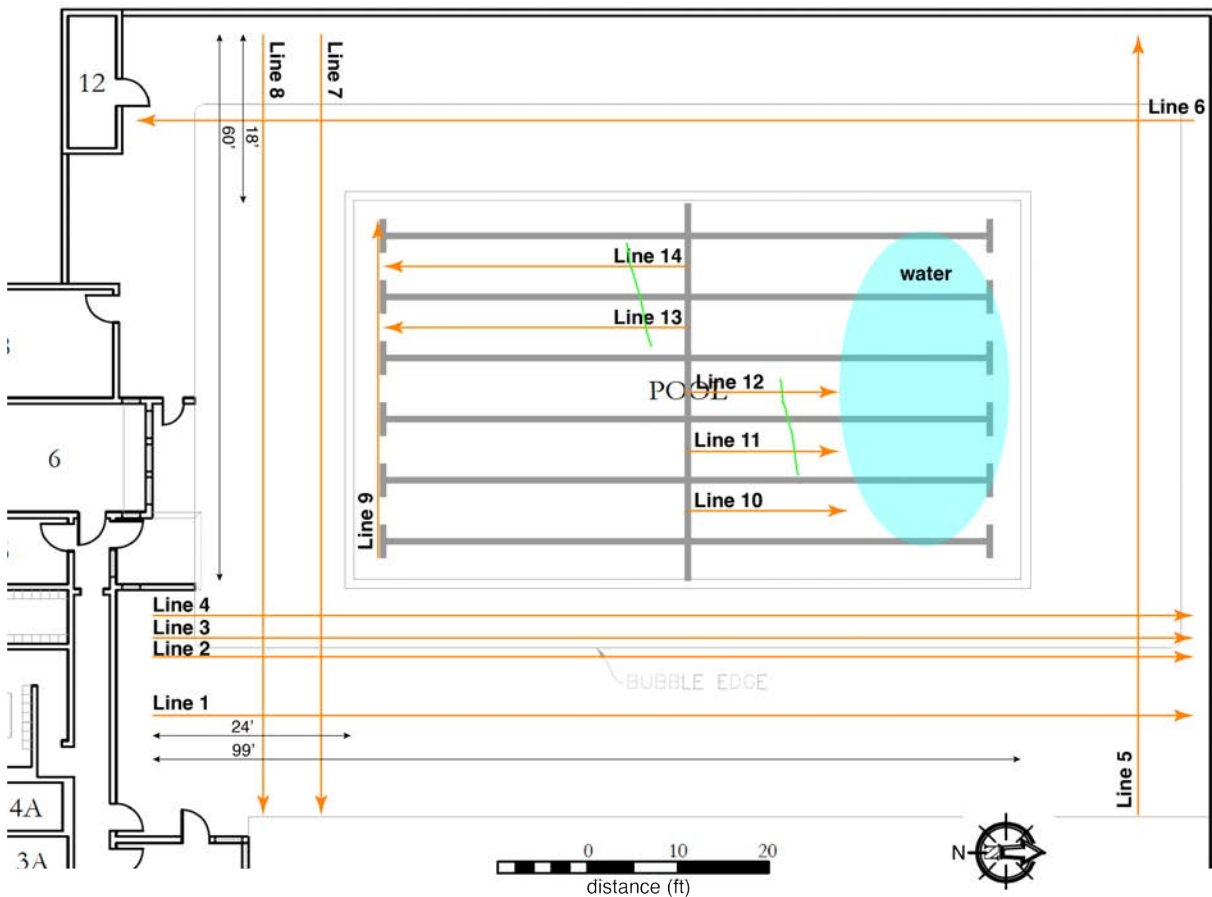
Figure 1: Map of NMT pool. North is to the right. Orange lines are locations of GPR profiles collected in 2026. Line numbers are near the start of each line (i.e., 0' on the profiles); arrowheads are at the line ends. Green lines are approximate locations of larger cracks in the pool liner.
